A10360 ULF Cable Summary of Fiber Break Investigation June 29, 1992

Subj: Results Of Post Mortem of ULF E-O Tube

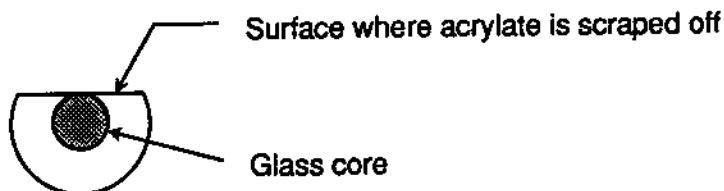
Investigation of the broken ends of the fibers showed that the acrylate buffer had been stripped from the glass core on one side of the fiber. An approximate cross-sectional view of the fiber is shown below. The buffer was stripped for about 0.25" on the natural fiber and 0.13" on the orange fiber. Microphotographs of the fiber ends were taken.

These fiber ends also had stripped buffers. On the orange fiber, the acrylate was stripped around the entire circumference for about 0.1" at the end. An additional approximate 0.025" length displayed stripped acrylate on one side only, similar to the figure above. The cladding on the natural fiber was stripped on one side only for about 0.15". There was no visible damage to the acrylate buffers of the blue and green fibers. Microphotographs of the fiber ends were taken.

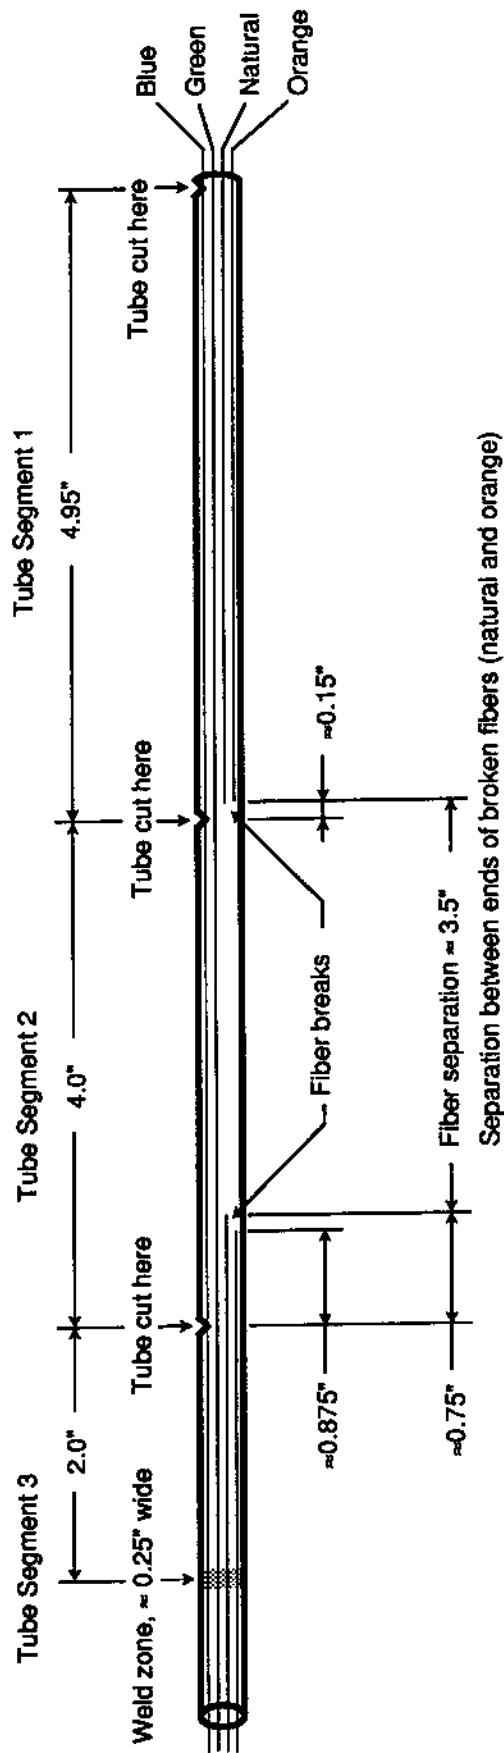
Diagram of Tube Cuts and Fiber Positions

When tube segment 1 (4.95") was removed, the orange and natural fibers moved with the tube as it was pulled away. The fiber breaks were found to be very close to the point where the tube was broken for removal (see diagram). A metal wire was pushed through this 4.95" section of tube to determine if any pieces of fiber remained in the tube. No fiber pieces were found.

The removal of tube segment 2 (4.0") revealed the ends of the two broken fibers (see diagram). The long spacing between the ends of the broken fibers indicated that the fiber break did not occur when the tube was cut. There were no specific events during handling which could have caused this separation, but it cannot be absolutely ruled out that handling caused the separation.

Note: The blue and green fibers were continuous over the three tube segments.
