STURM2 Meeting Materials

2011.3.23

Effects of Earthquake

KEKBトンネル マグネット関係簡易調査速報

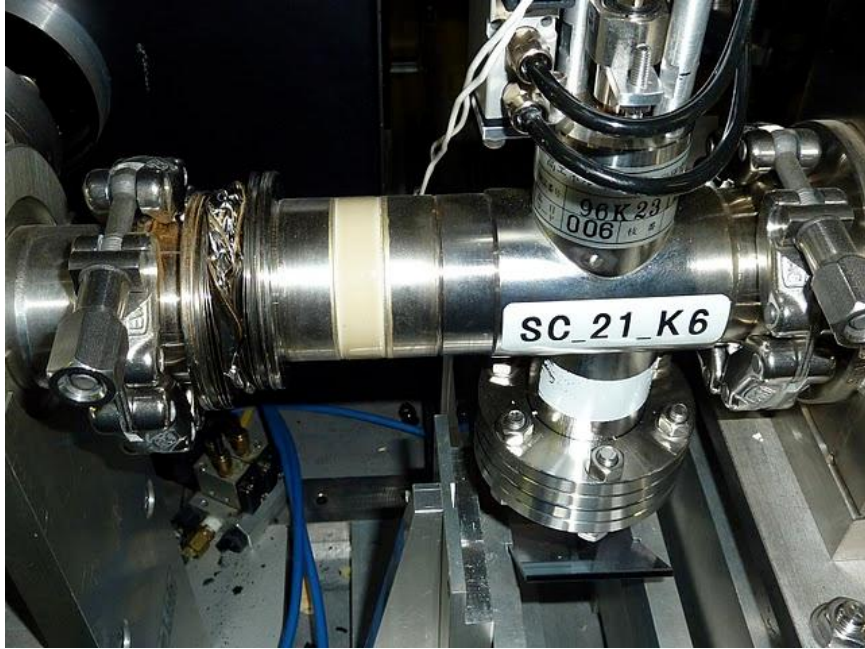
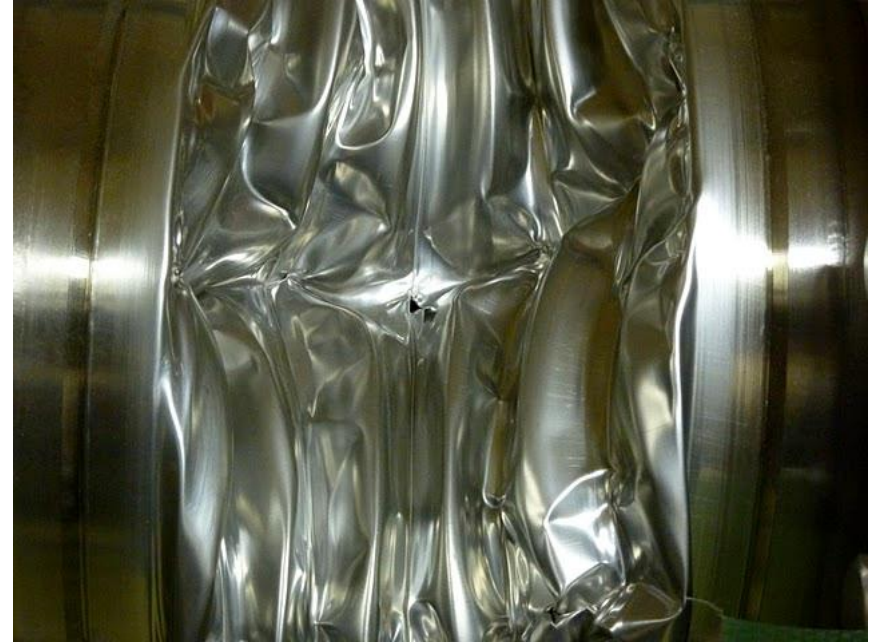
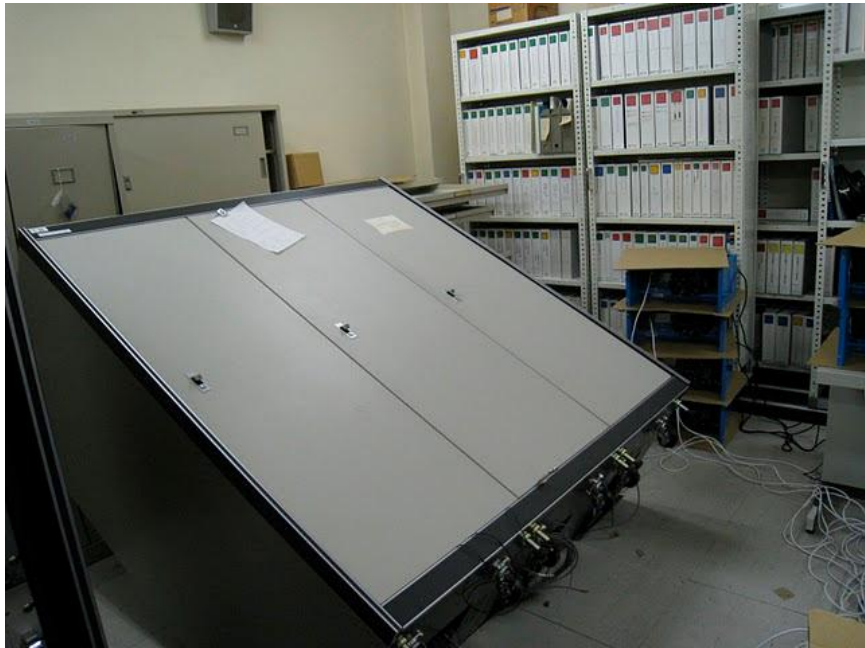
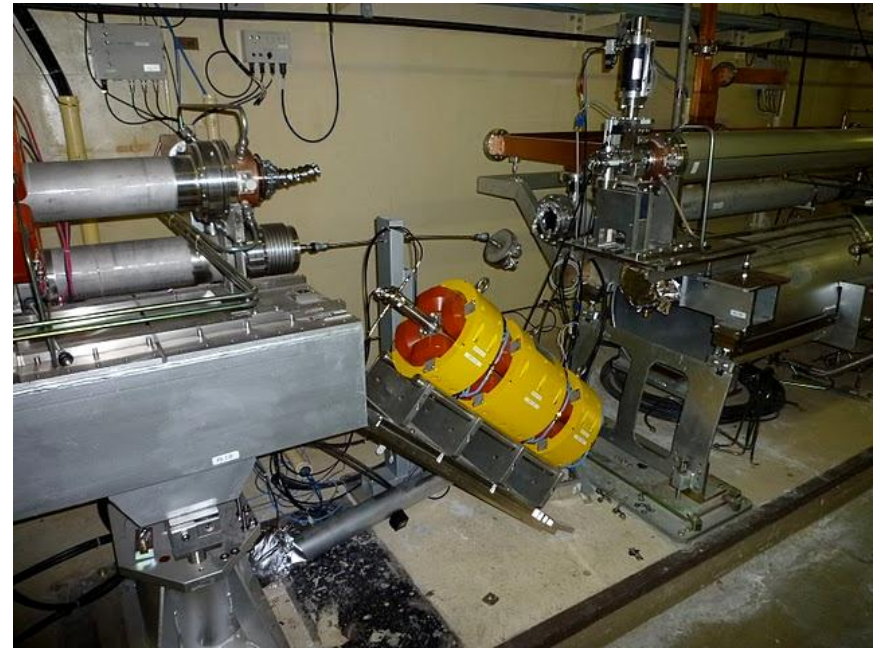
- No immediately visible damage to accelerator components that are still in KEKB tunnel.
 - Linac not so lucky – many damaged bellows sections, plus other damage seen. Re-mounting and re-alignment work also needed (on bright side, that had been planned anyway).

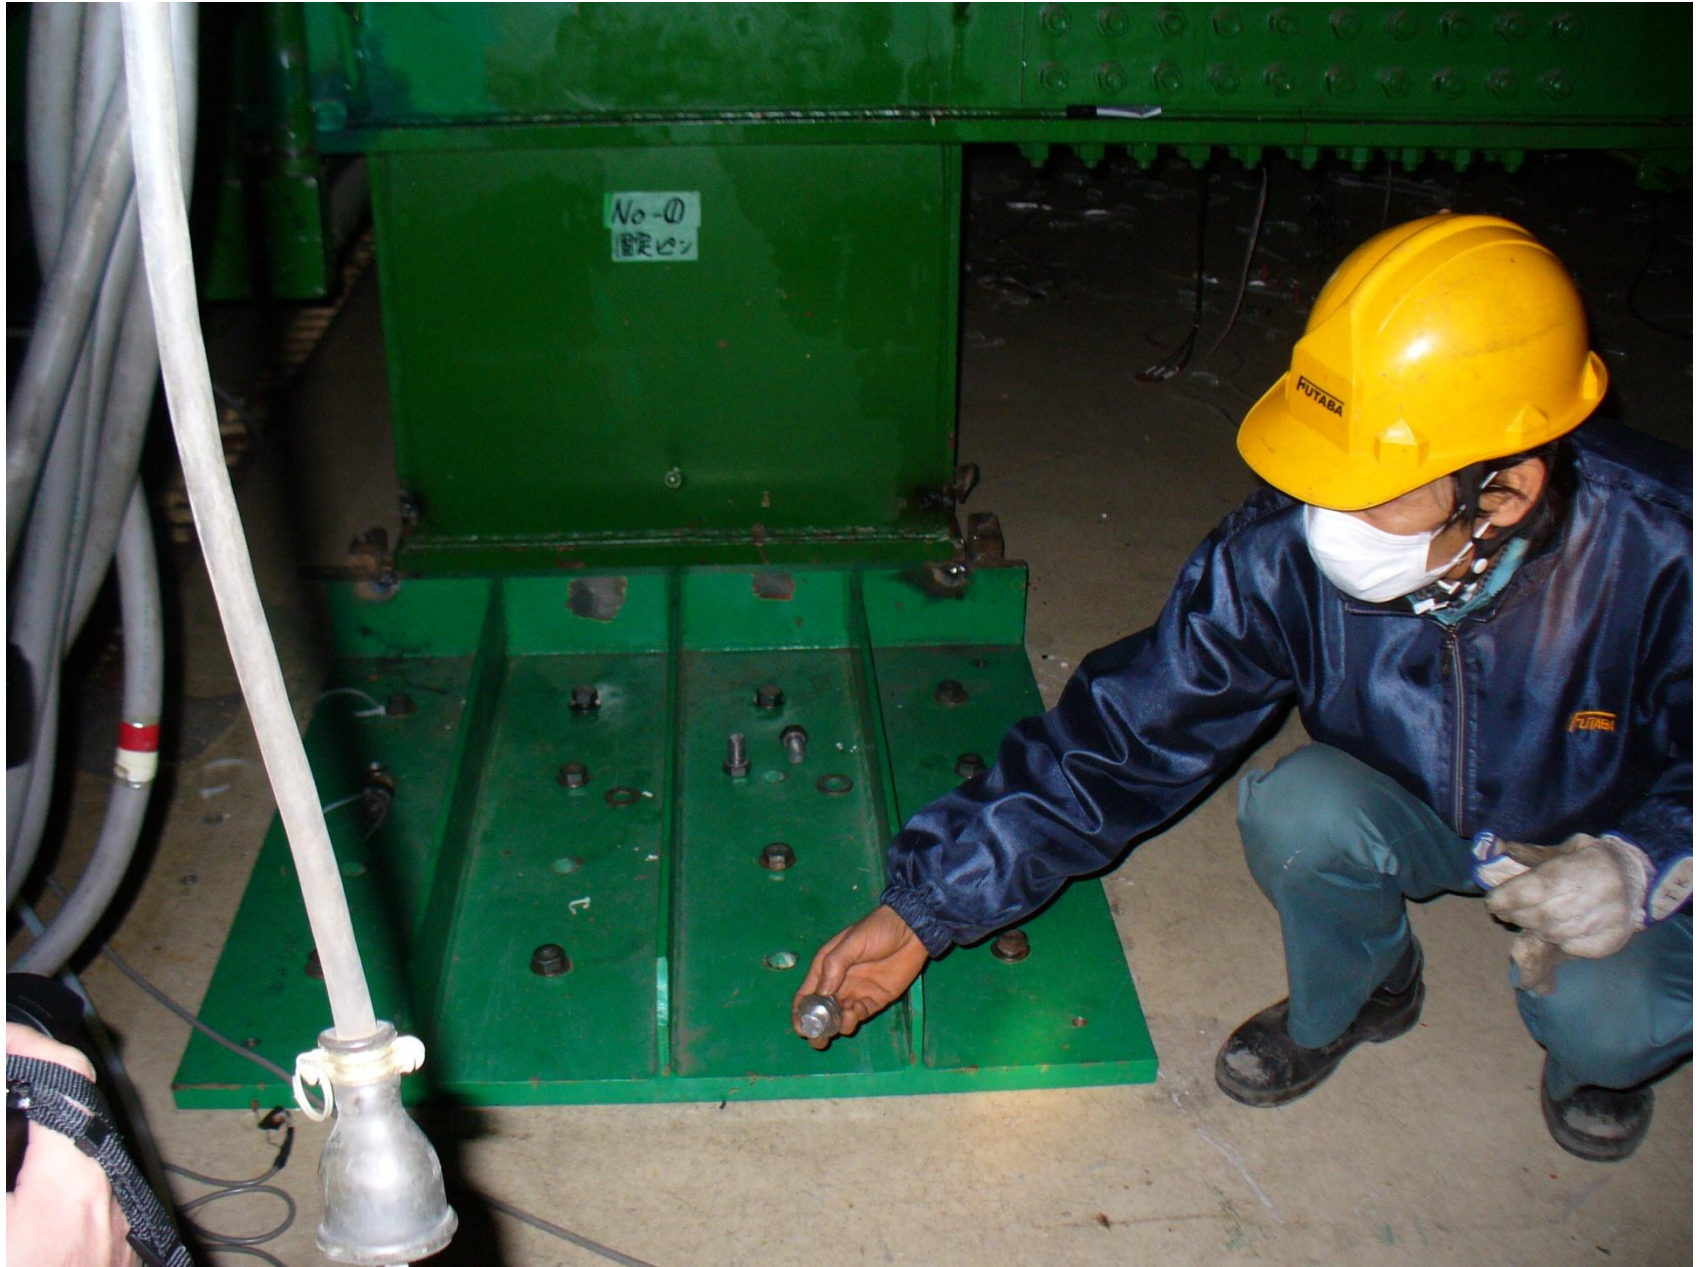
- Survey work needed to re-establish tracking network monuments.
 - Belle detached from anchor plate, but is still on rails.
 - Some new rainwater leaks found in tunnel.

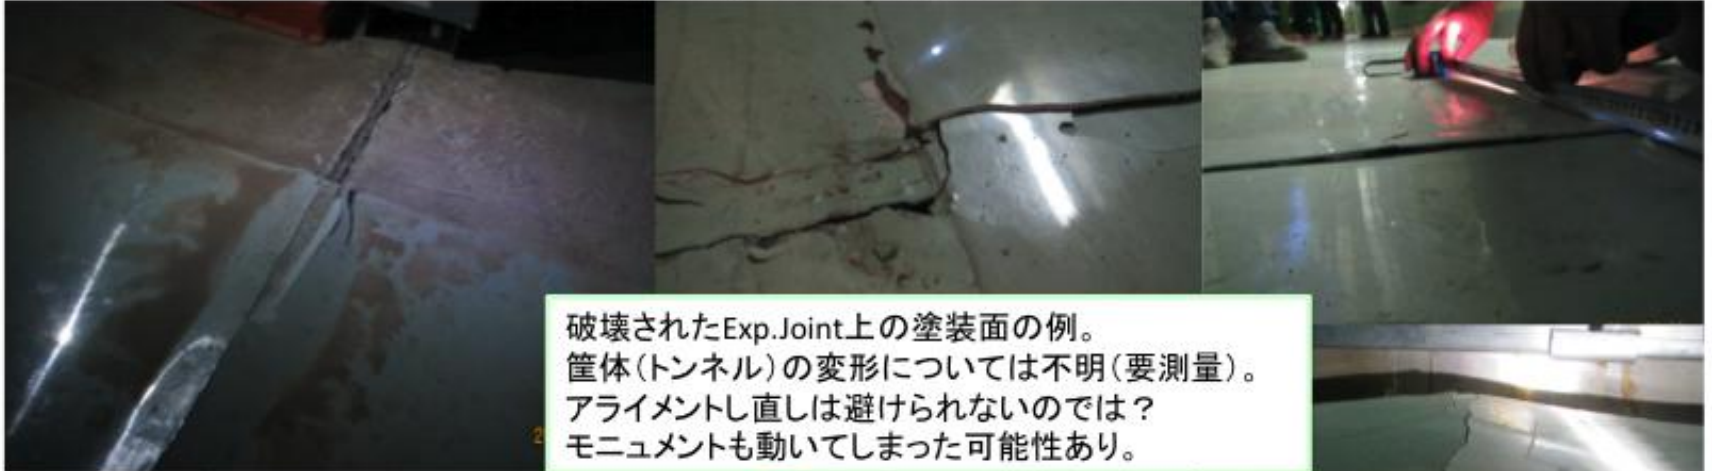
破壊されたExp.Joint上の塗装面の例。
筐体(トンネル)の変形については不明(要測量)。
アライメントし直しは避けられないのでは？
モニュメントも動いてしまった可能性あり。

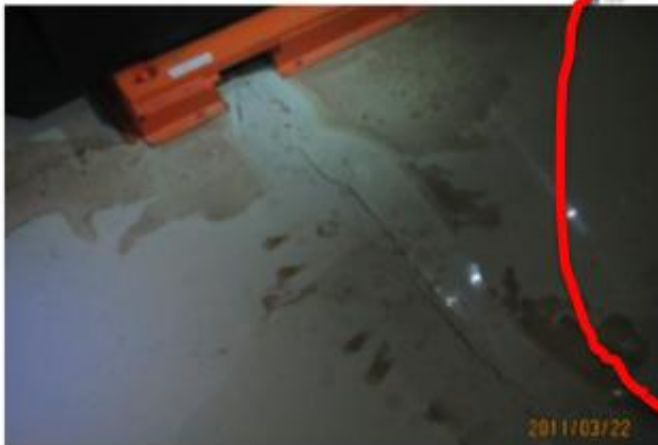
NL287 Exp.Joint

液状化して泥水が隙間から吹き出した痕跡あり

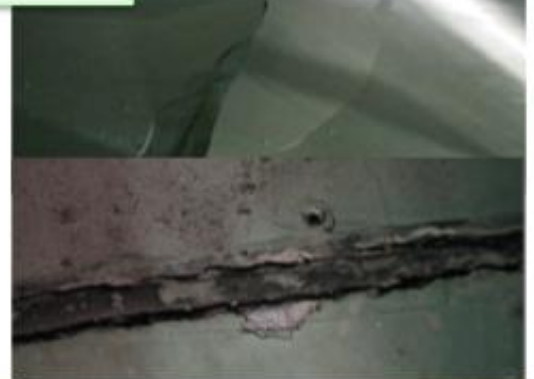
OL028、OR112 Exp.Joint
隙間。大穂側が上がっている。

隙間が開いたExp.Jointの上の
天井からは雨漏りしている箇所あり。ブルーシート
でマグネットを覆った。
