2-AUG-82 DUMAND IR: 13-82

SUBJECT: DeSteiguer Cruise Data Analysis

FROM: P. Gorham

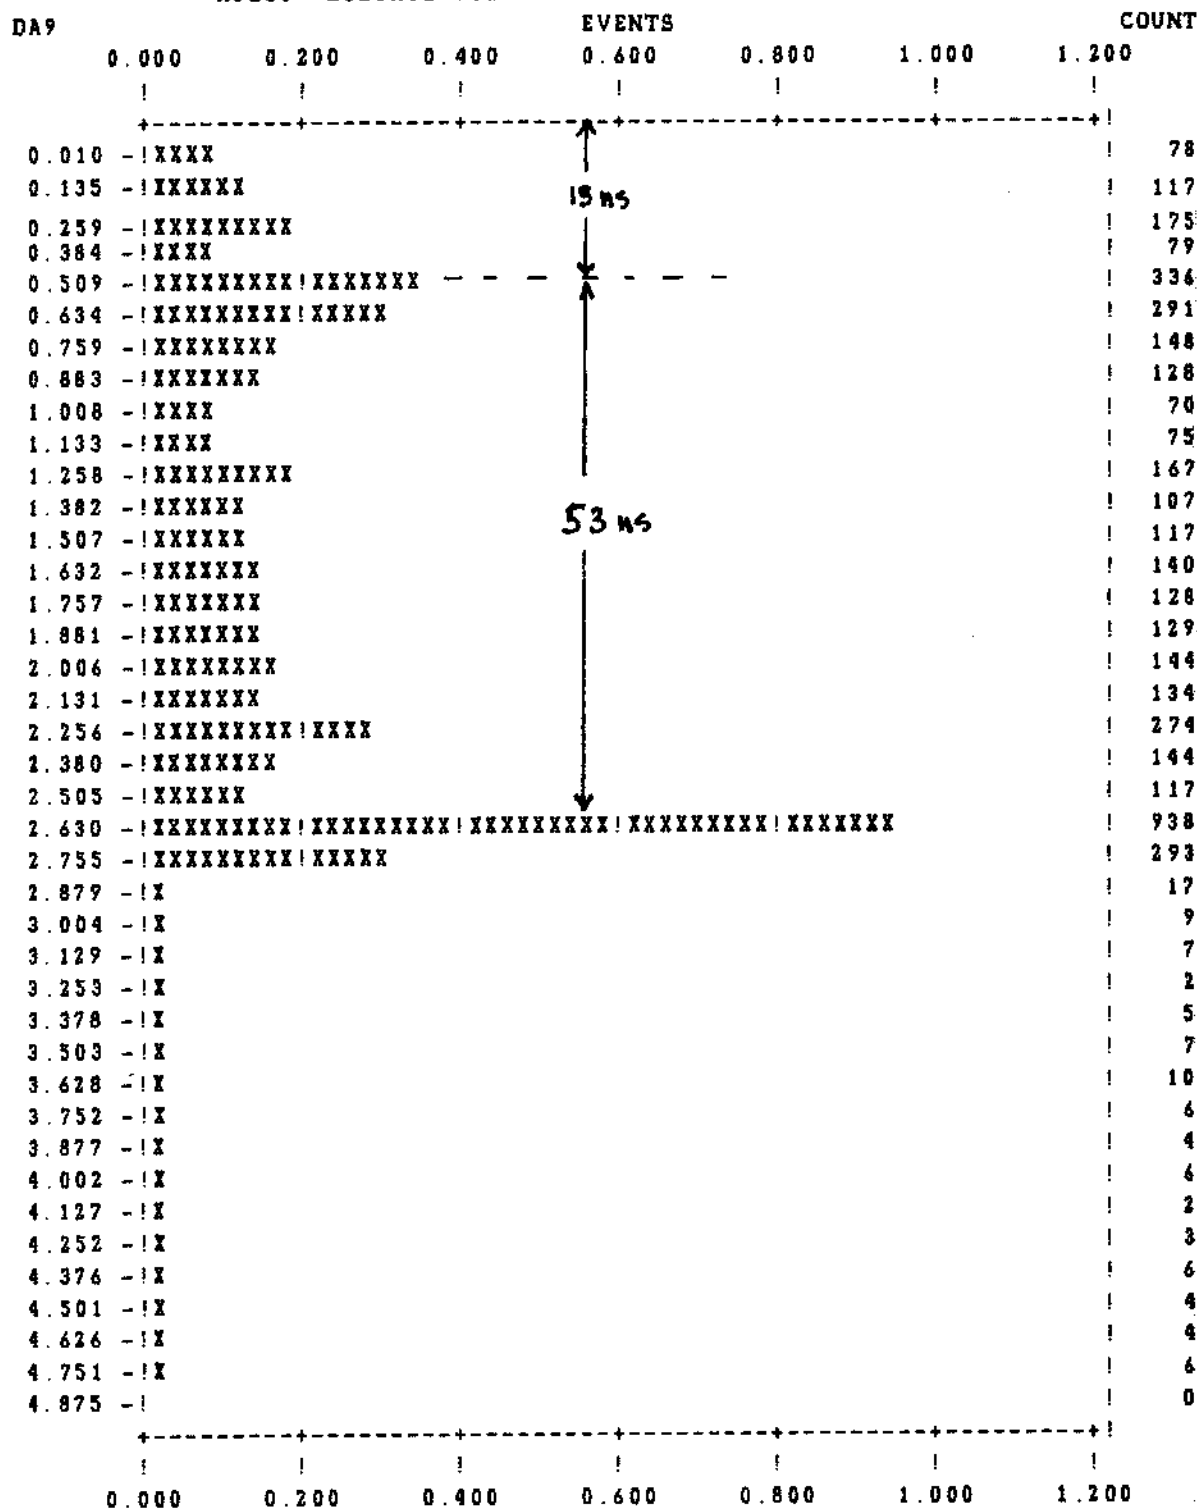
Fig. 1

At this point in the analysis a variety of histograms and scatter plots were made; a number of these are shown (figures 1-7). The plots which first showed significant irregularity were the "counts per TDC channel" histograms (fig.s 1,2) for run 4, which was a short run (330 sec.) supposedly dominated by random coincidences, due to the high singles rates. This means that the plot should be essentially "flat" in time; the noise should be an effective random-number generator.

However, a definite time structure can be seen in the plot, and it is not limited to this run alone, but shows up in all the runs, and in all the tubes with almost identical form (fig.s 3-7). Two prominent peaks in the TDC values are seen, and appear in identical channels for all tubes. In particular, the peak at ch. 270 consists of as much as

PMT # 1  
 4-fold coincidence  
 RUN 4 only  
 no pulser or LED events

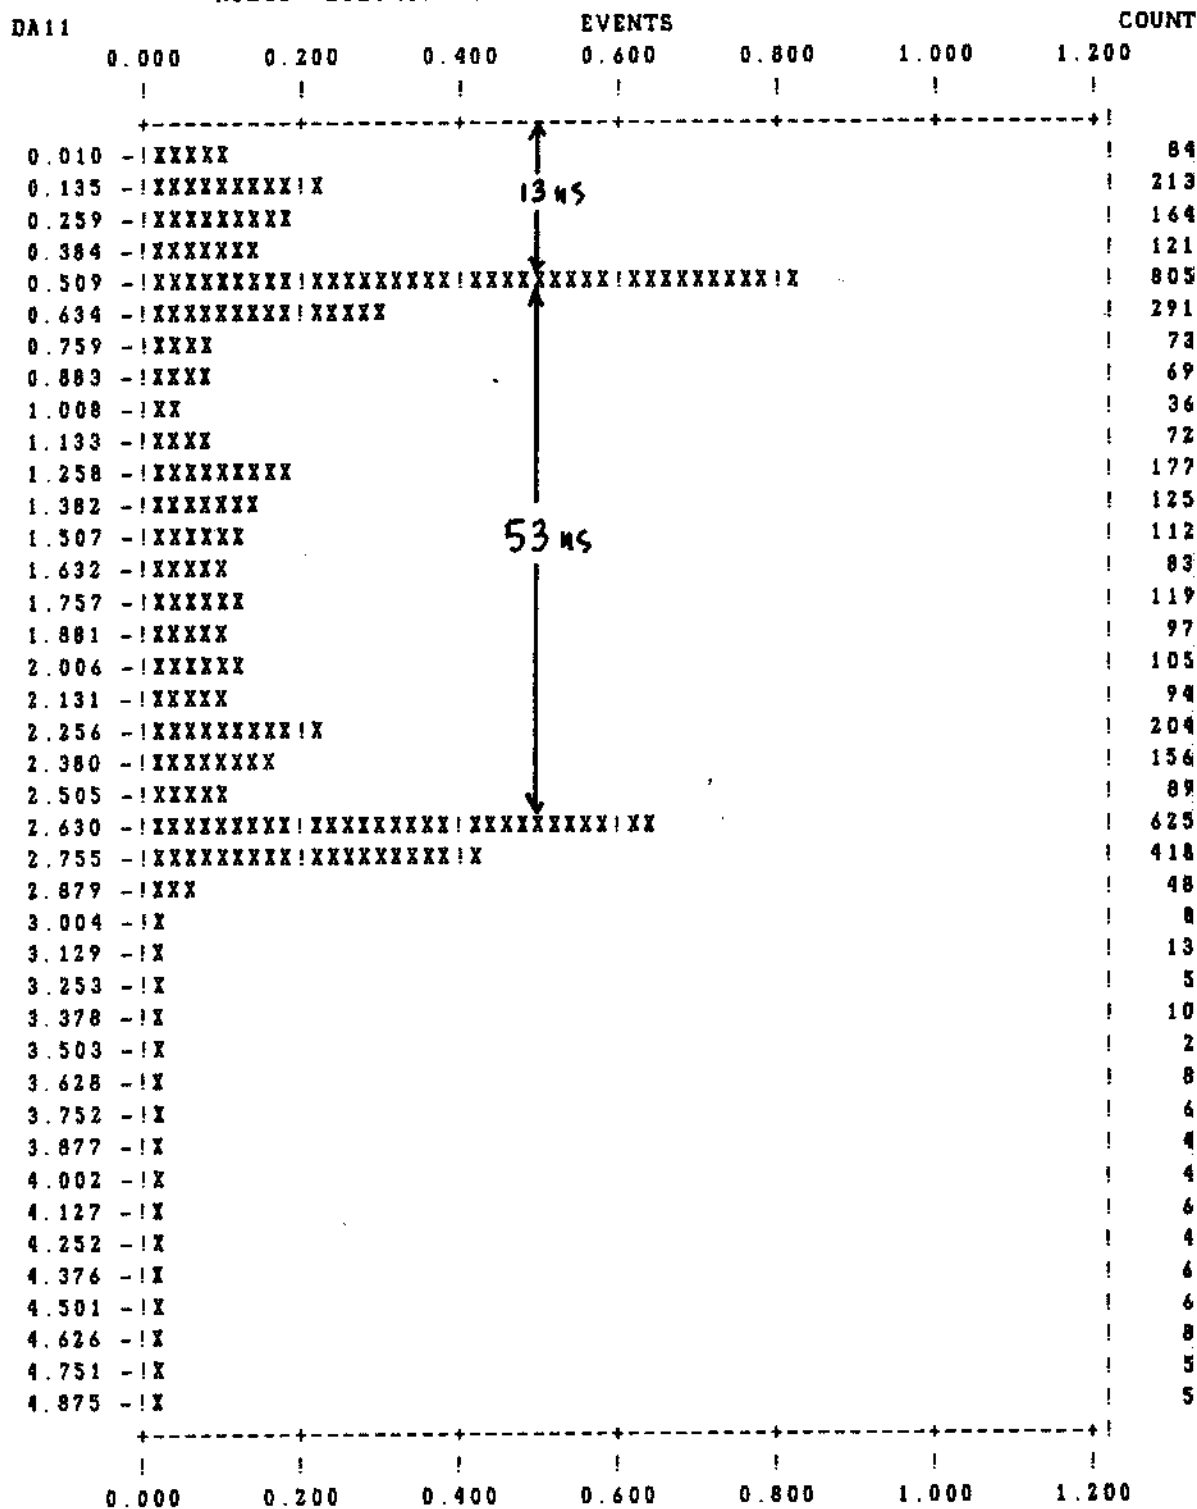
Fig. 2

PMT #3  
4-fold coincidence  
RUN 4 only  
no pulser or LED events

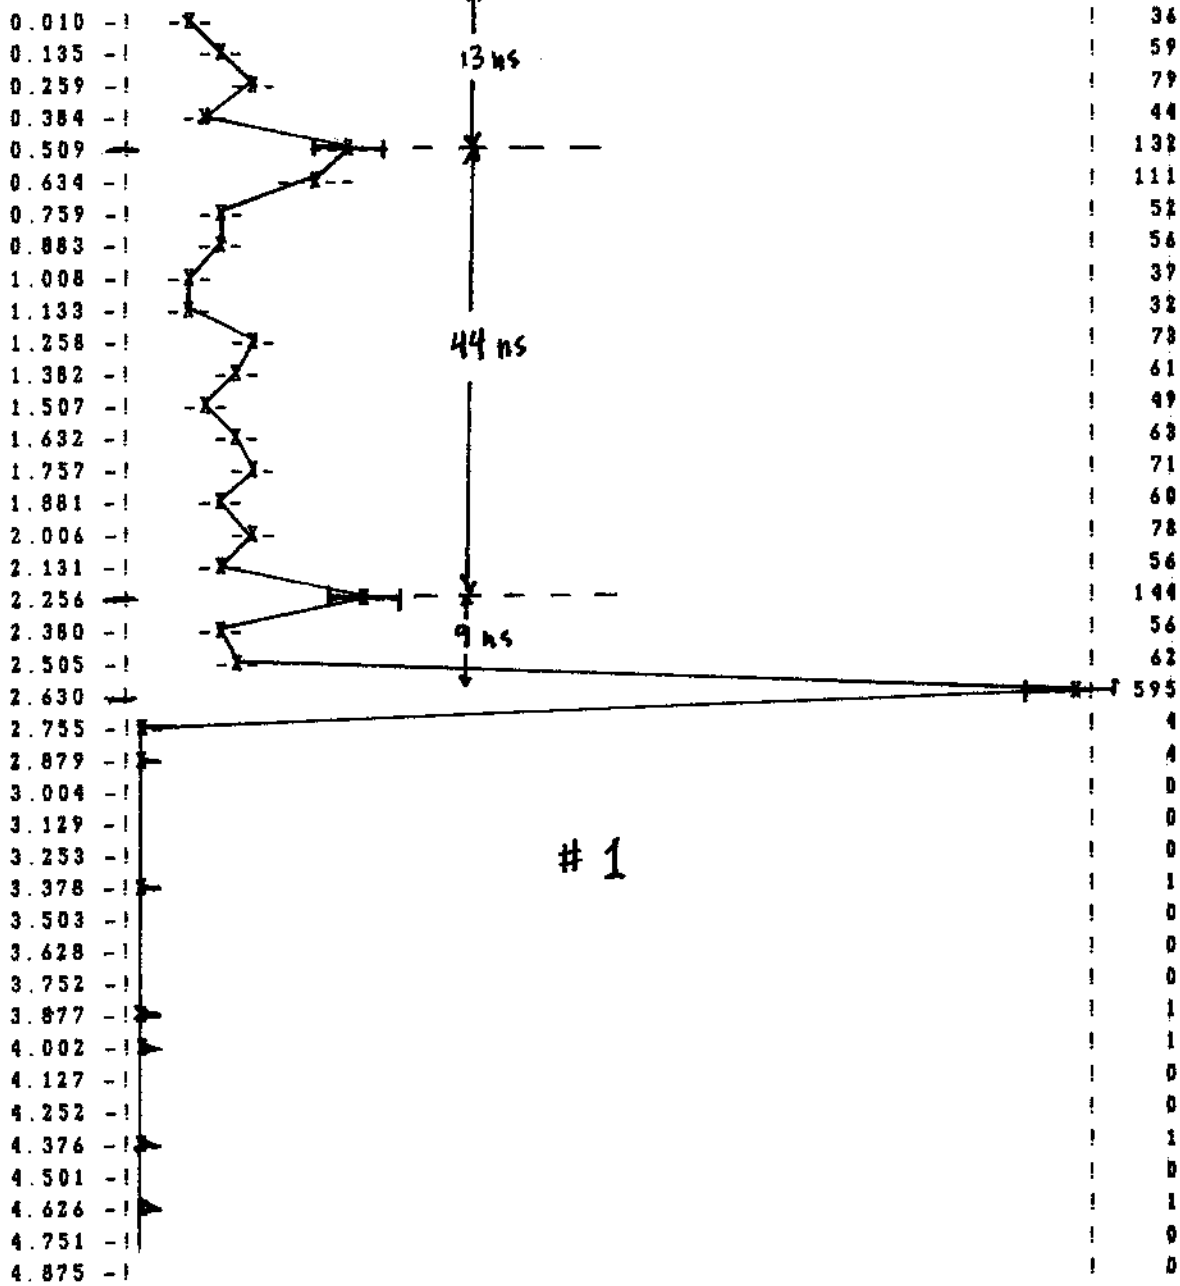
Fig. 3

25 percent of all of the events for each tube. In addition, some of the tubes show even further structure with intermediate peaks occurring, and most show a kind of "hole" at about ch. 100.

RUNS 16-32 combined  
No pulser or LED events  
(4-folds)

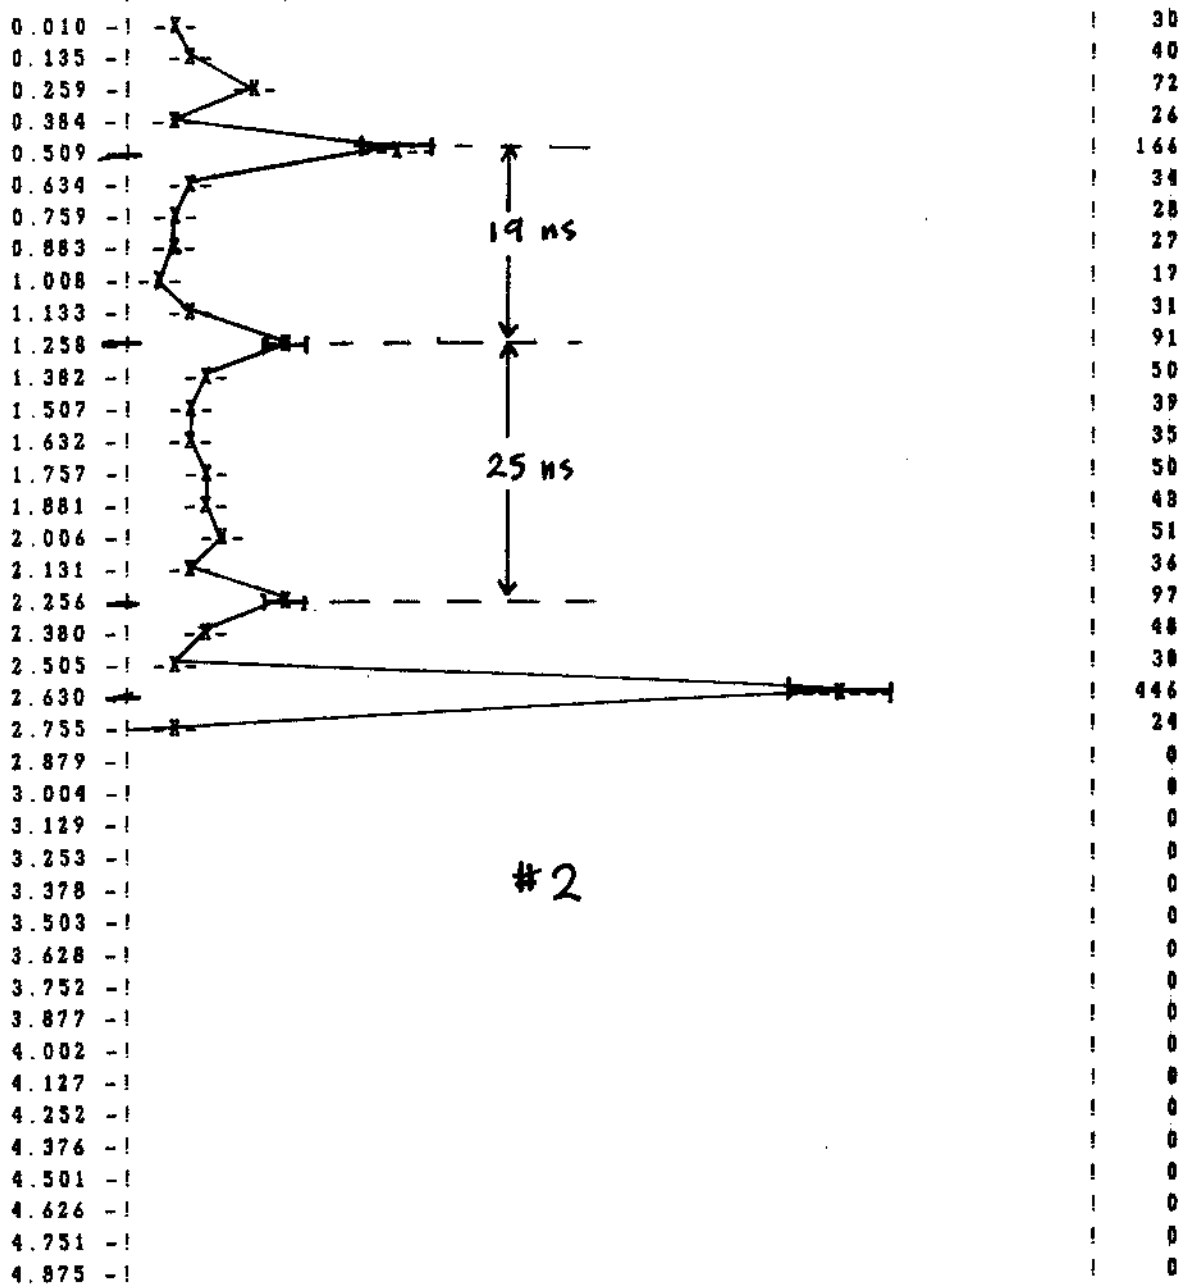
Fig. 4

Runs 16-32 combined  
 no pulser or LED events  
 (4-folds)

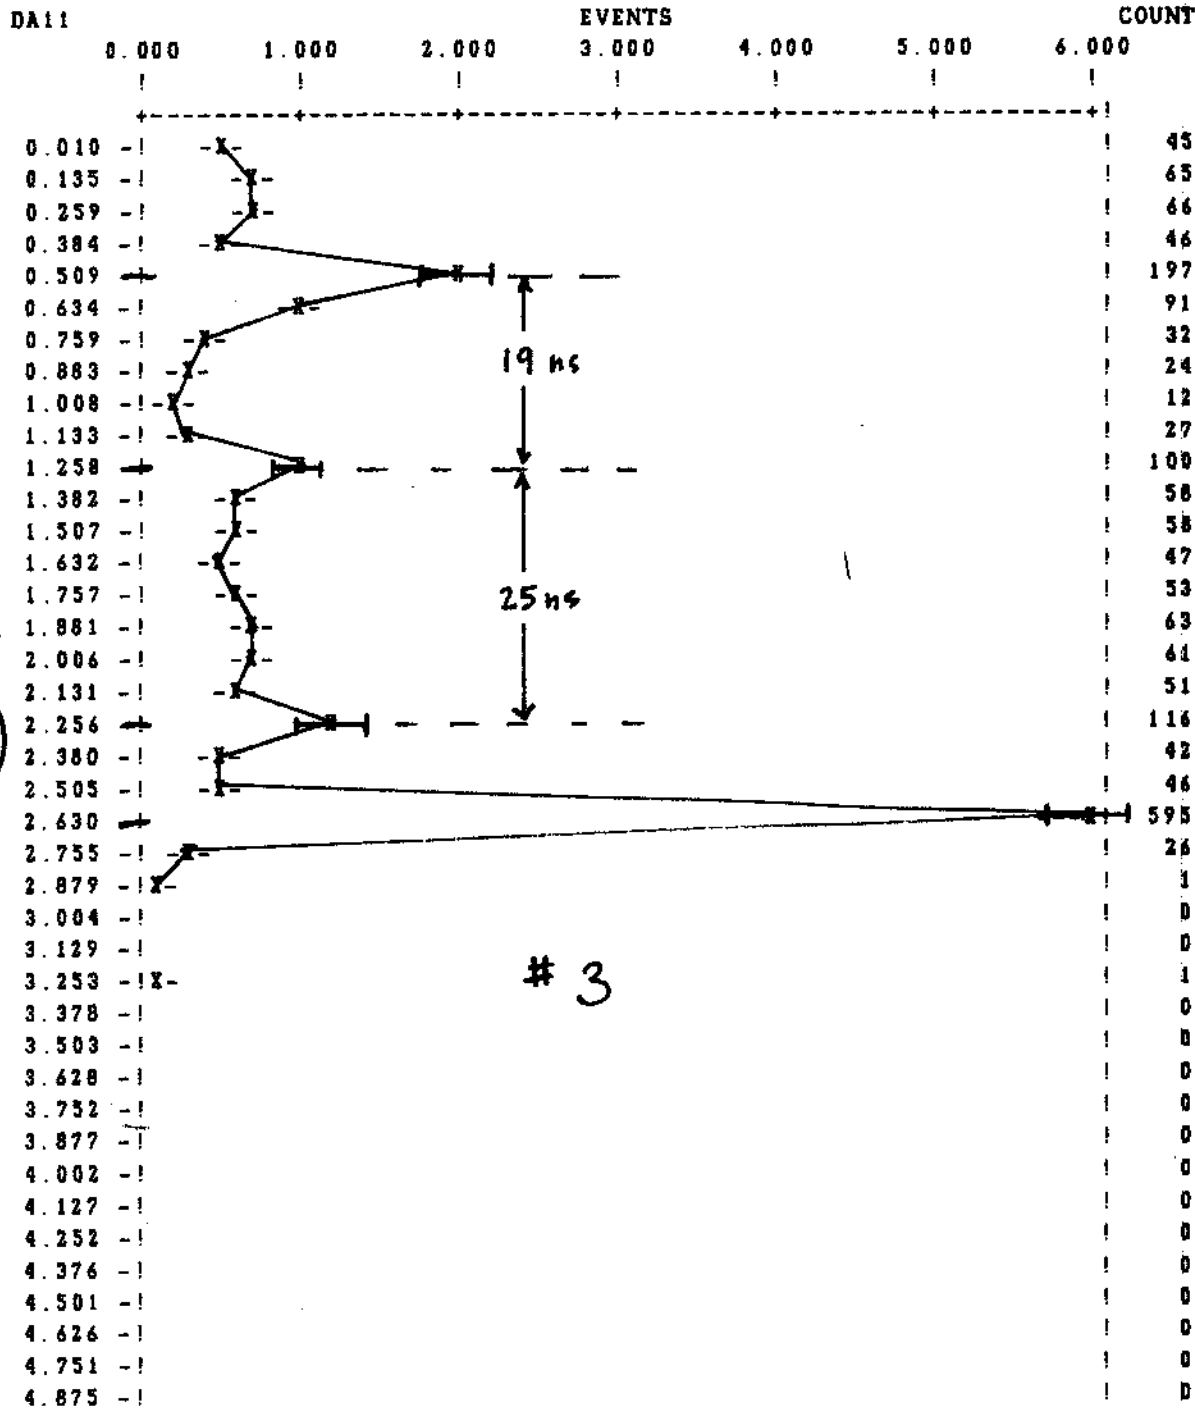
Fig. 5

Runs 16-32 combined  
no pulser or LED events  
(4-folds)

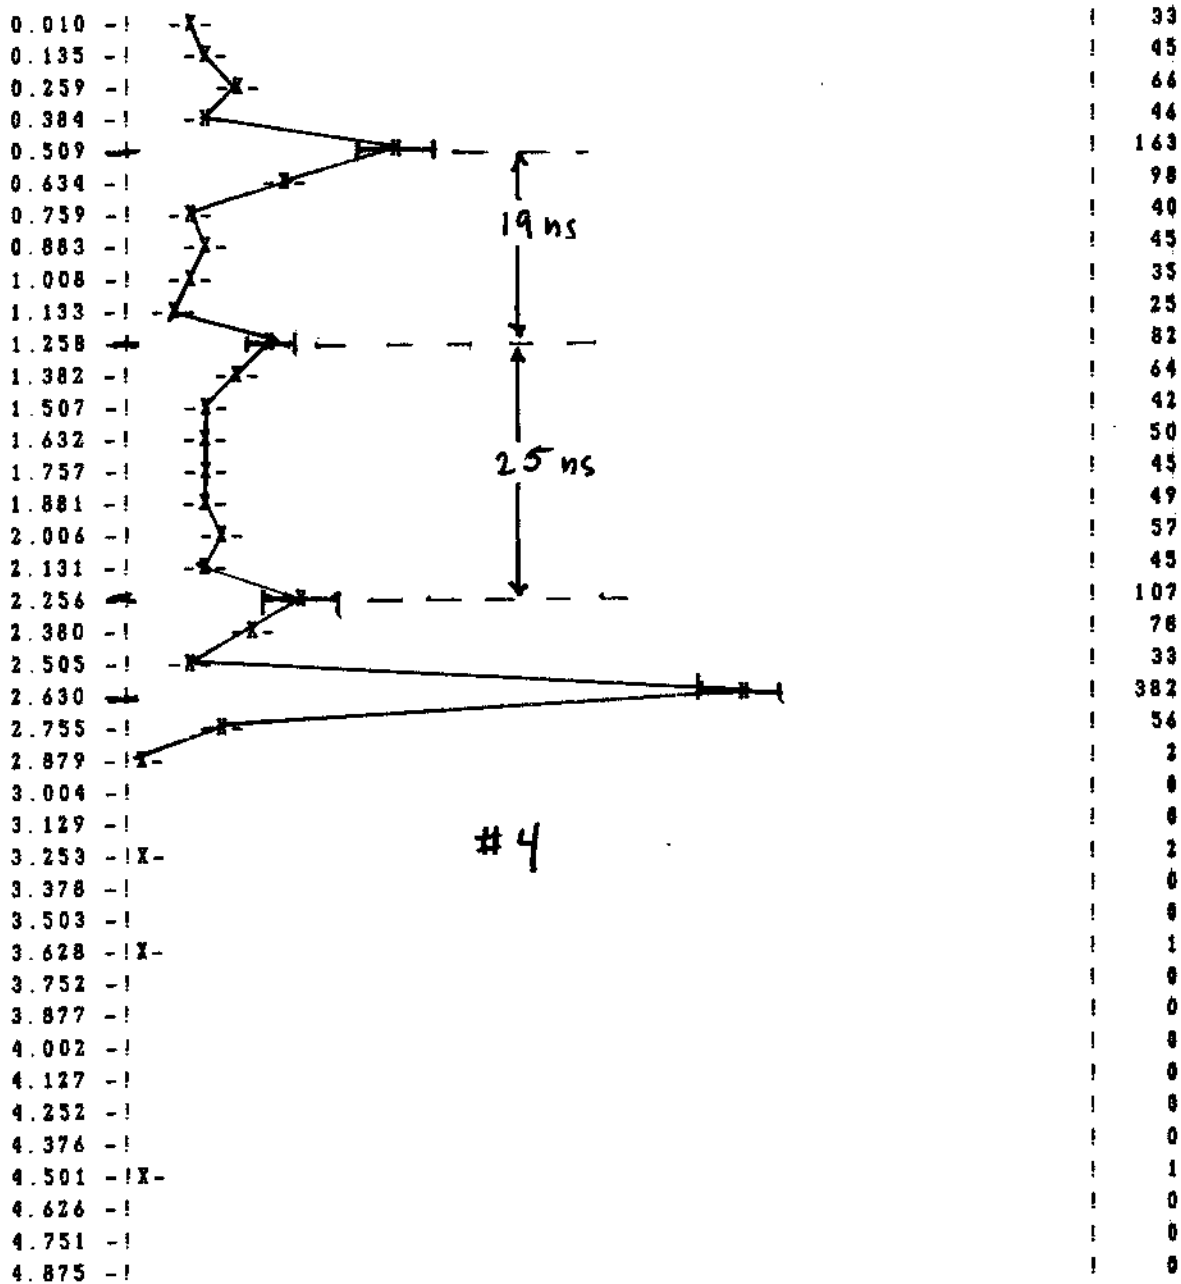
Fig. 6

Runs 16-32 combined  
 no pulser or LED events  
 (4-folds)

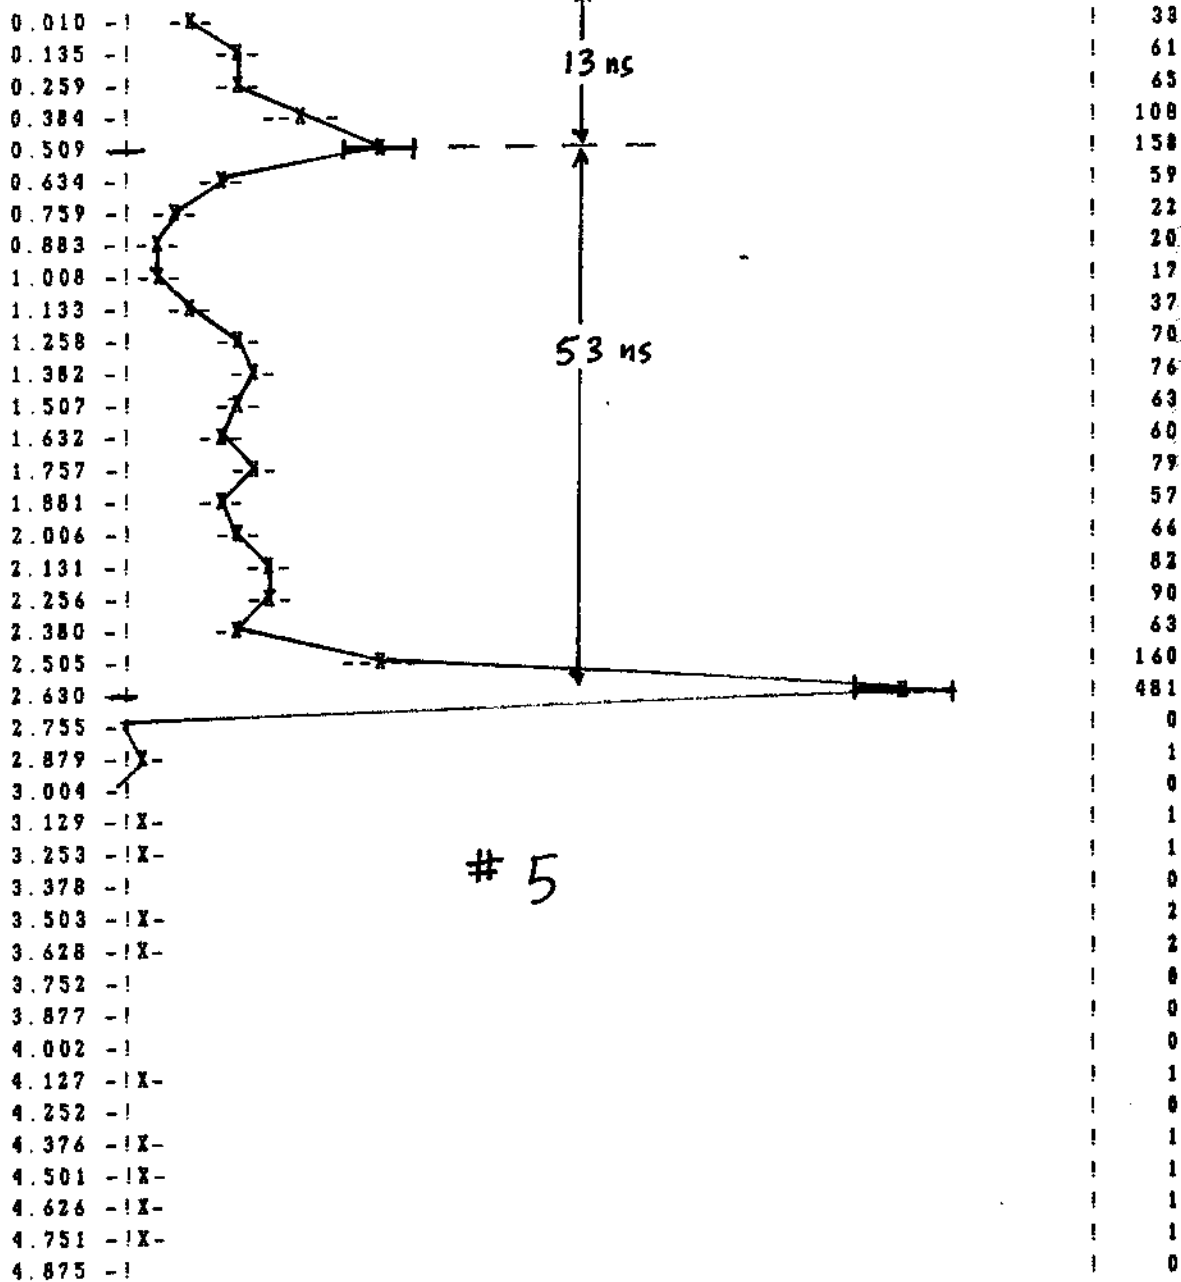
Fig. 7

Runs 16-32 combined  
 no pulser or LED events  
 (4-folds)
