# Status and future plans of the BaBar Silicon Vertex Tracker

Michael Wilson  
University of California, Santa Cruz

The 11th International Workshop on Vertex Detectors  
Kailua-Kona, Hawaii, USA  
4 November 2002

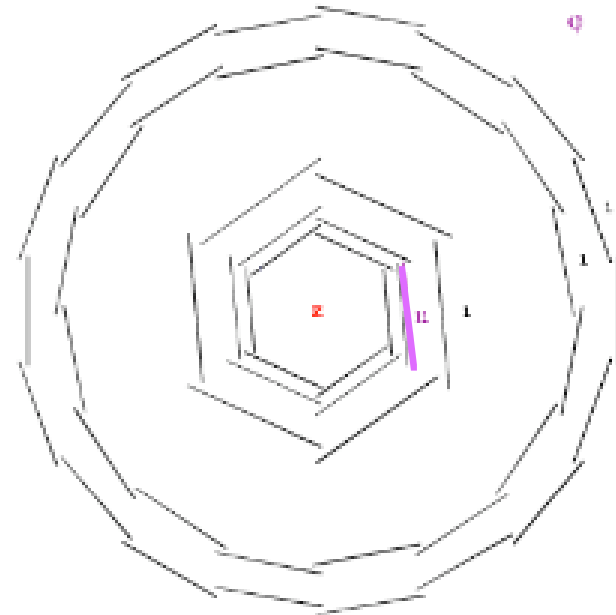
# Module Status

- 104 half-modules, 208 readout sections
- **only 3 sections are not read-out**  
(6 were fixed this summer, more later...)
- no sections lost to radiation damage

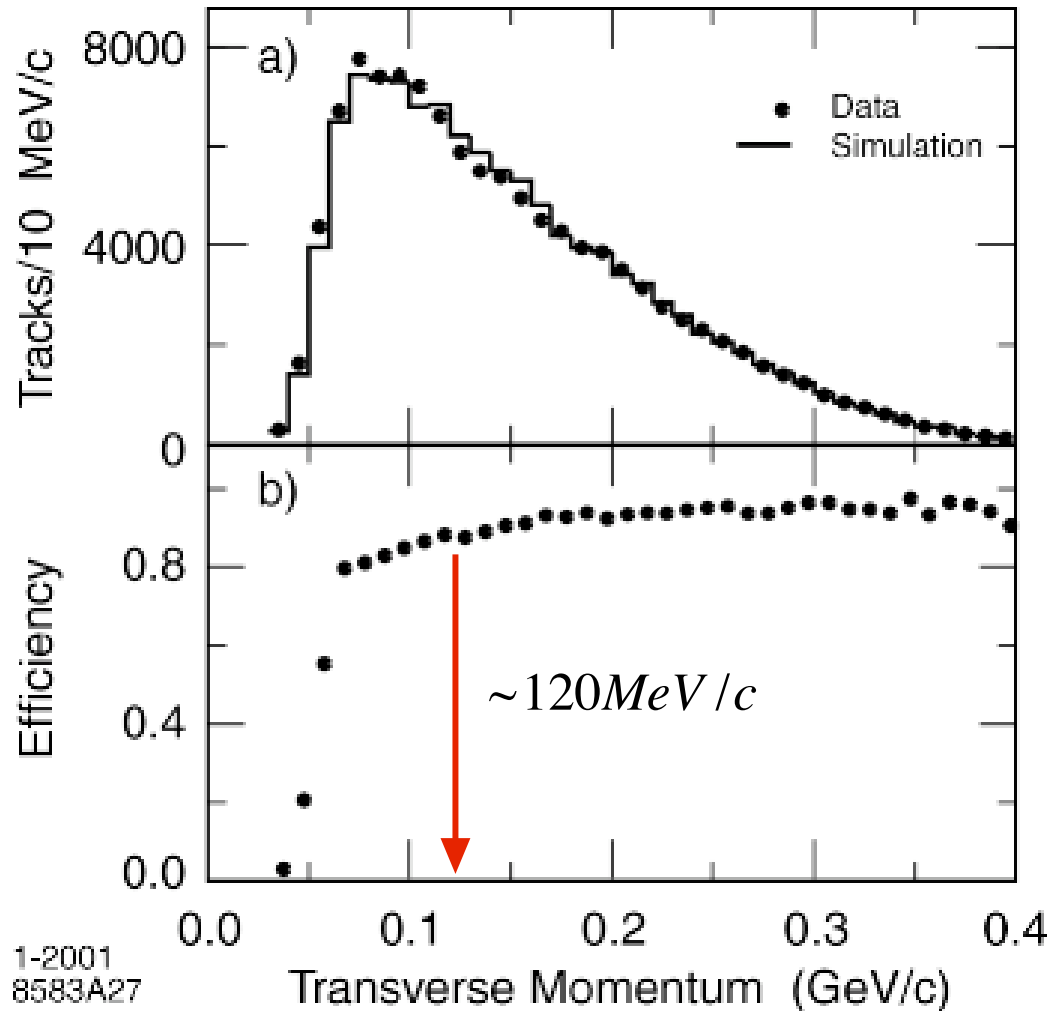
# Tracking

- slow pion detection efficiency with both SVT and Drift Chamber
- SVT significantly extends charged particle detection down to  $\sim 50 \text{ MeV}/c$
- Important for  $D^{*+} \rightarrow D^0 \pi^+$

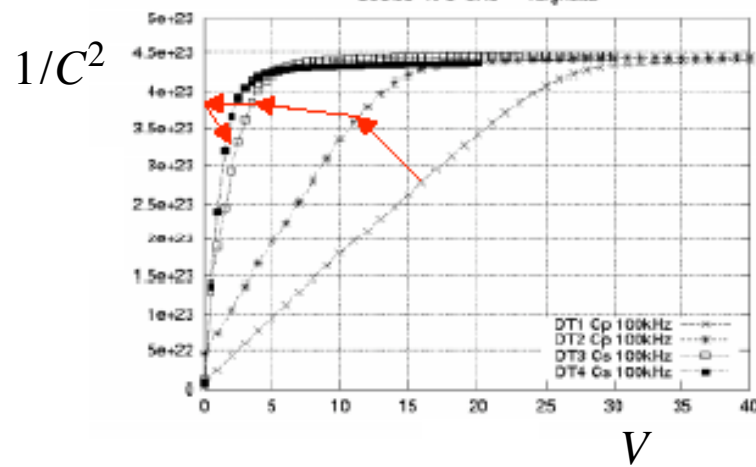
# Silicon Radiation Tests

electron beam

SD3.06 TF3 GRD - Elettra

electron beam on Cu target

SD3.03 TF3 GRD - Targhetta

- shows type inversion  $\sim 2 \square 3 \text{MRad}$
- results agree with NIEL hypothesis (not obvious or expected)
- leakage current increase  $\sim 2 \square \text{A} / \text{MRad} \square \text{cm}^2$
- Agrees with in-situ measurements

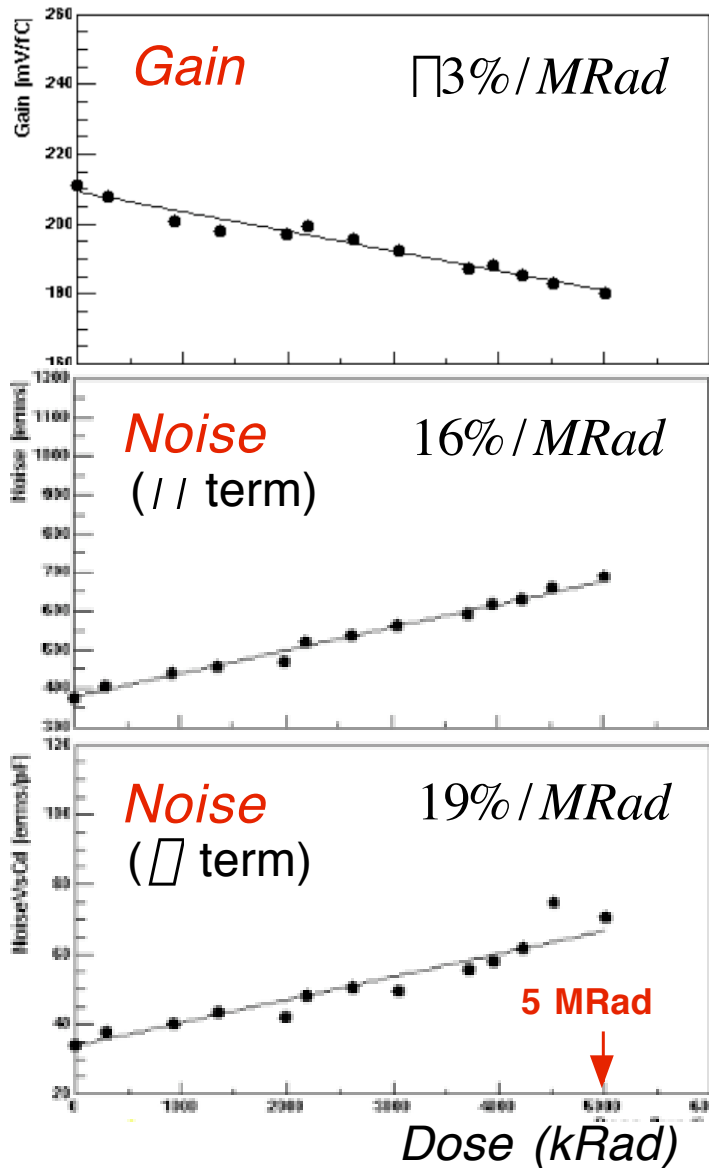
# Front-end (ATOM) Radiation Tests

- Tests performed with  $Co^{60}$  source at LBL and SLAC
- Chips powered and running during irradiation
- No digital failures up to 5 MRad

$$Noise = \square + \square C_{load}$$

Significant decrease in performance of inner layers around 5MRad (S/N  $\sim$  10)

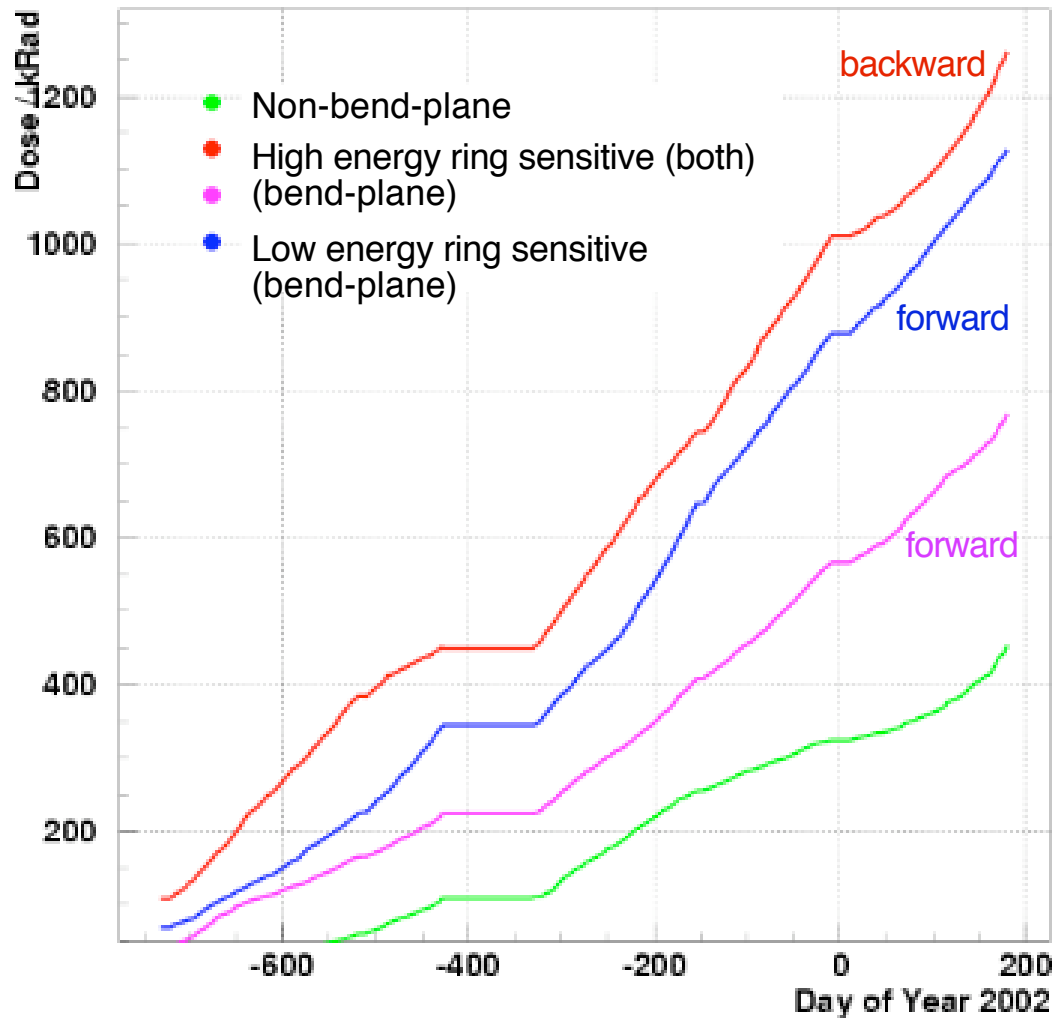
SVT PIN Diode Accumulated Dose

- Most damaged areas in the bend plane ~1.2MRad
- Typical “non-bend-plane” diode ~ 400kRad

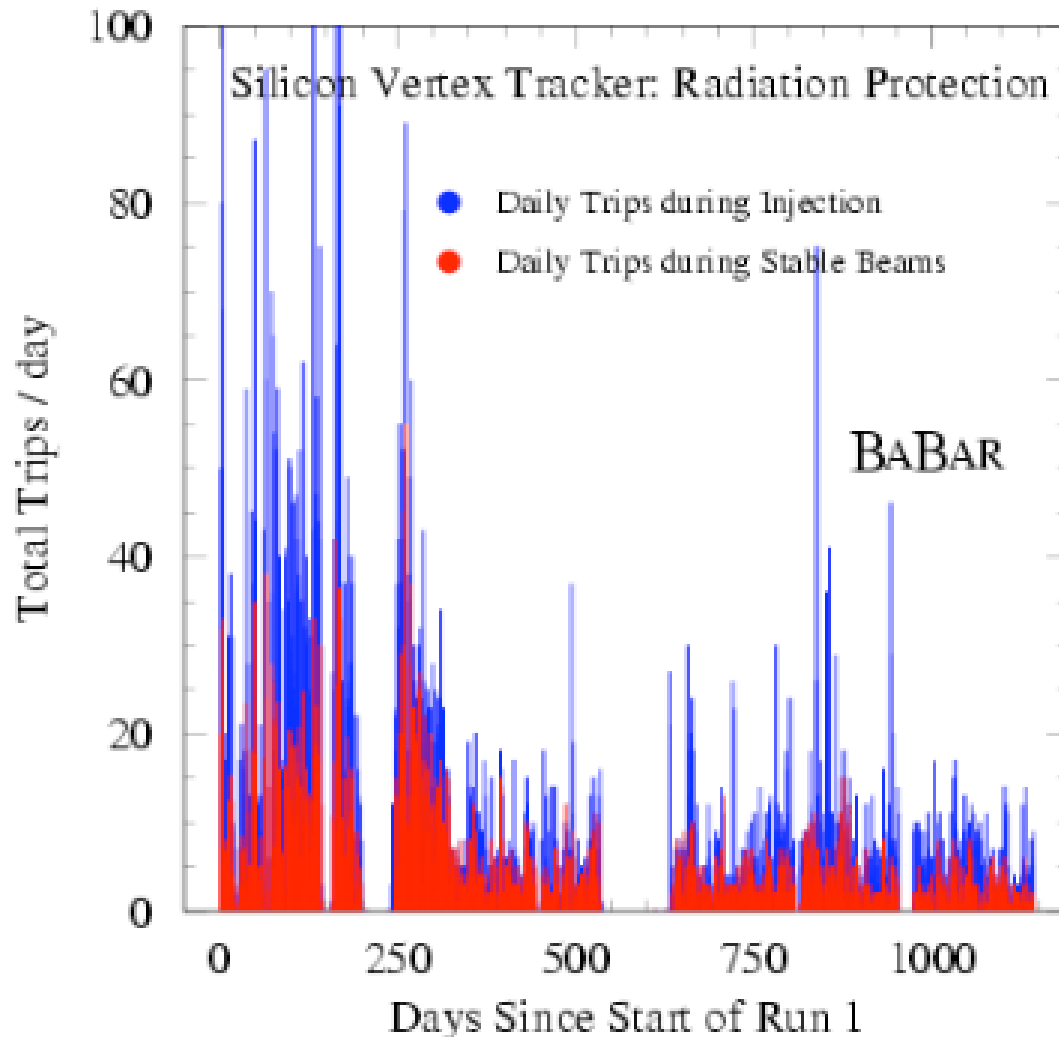
# Radiation Protection

- 4 bend plane (AKA “mid-plane”) diodes used in abort logic
- We have both a “fast abort” (hardware  $\sim 400\mu\text{s}$ ) and a “slow abort” (several minutes)
- dose rate thresholds  $\sim 1000\text{mR/s}$  (starting June 2002)
- **No major damage due to radiation since installation!**

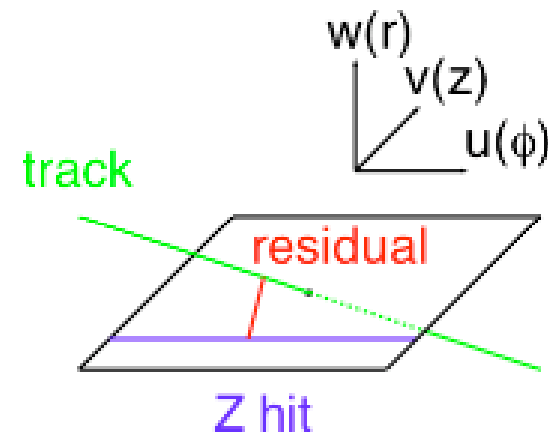
## *SVT Local Alignment*

- Each of 340 wafers described by 6 parameters + *curvature*
- Calculate residuals, minimize  $\chi^2$

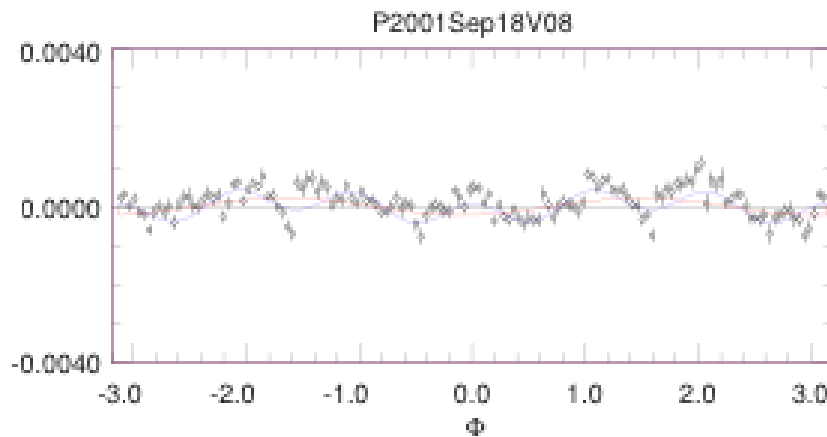
# Mu-pair misdistance

distance between  $\mu^+\mu^-$  tracks produced at the IP  
as a function of  $\Phi$

← *old alignment*

← *new alignment!*

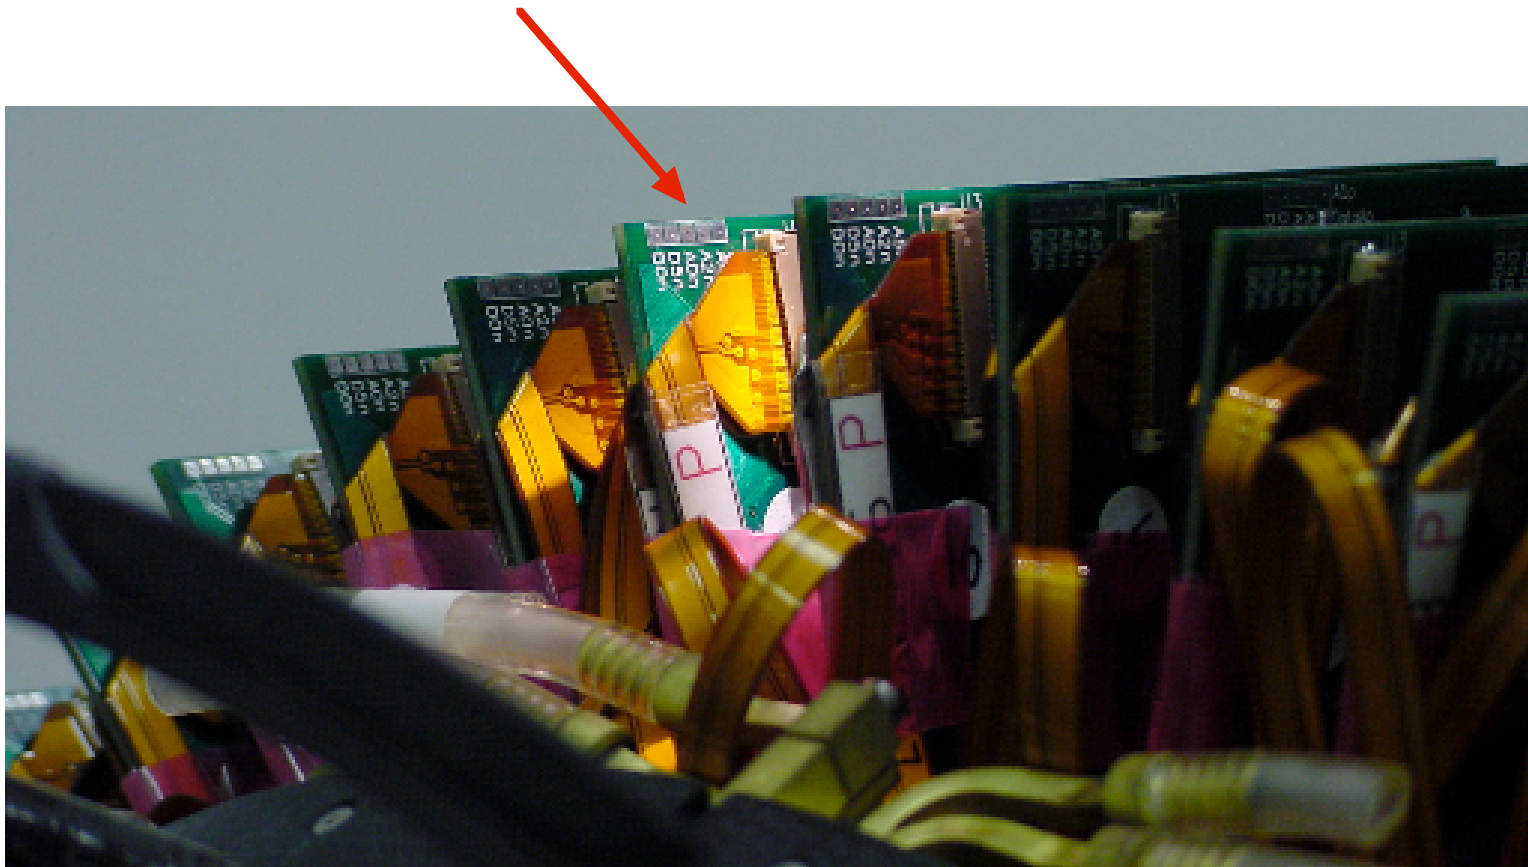
# Slipped Kapton Tails

(fixed two readout sections  
by re-inserting tails)

Rotated just a little bit...
