Preamp Carrier Board Periodic Noise Issue and Solution

IDLAB 3/27/2013

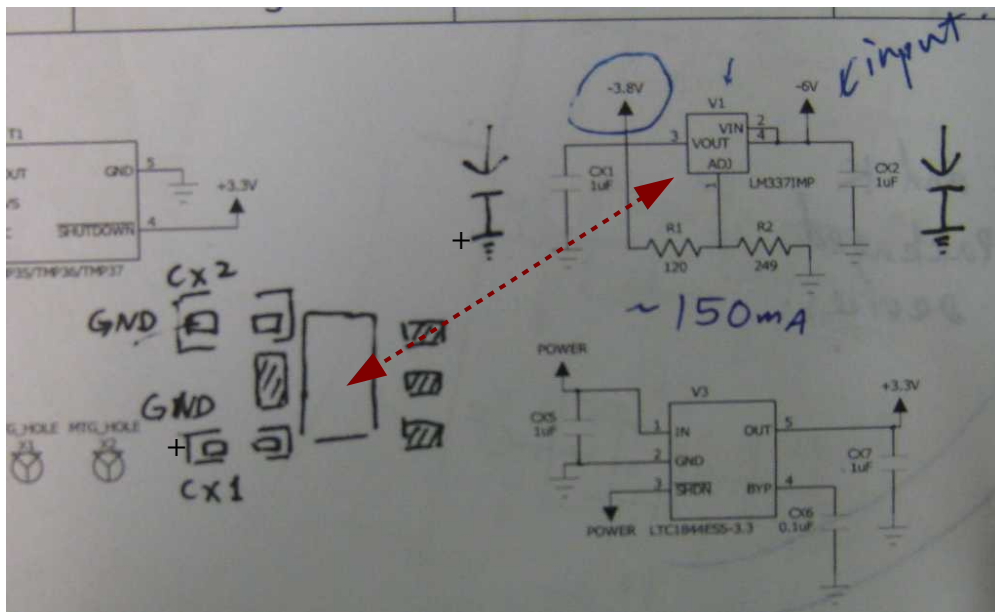
Pic-Setup3: Where and how I soldered the Tantalum capacitors.

1. Desolder CX1 and CX2 on the preamp carrier board.
2. Follow the diagram Pic-Setup3.
The '+' side(The side closer to "bar") of the Tantalum capacitor should be connected to 'GND' for both CX1 and CX2.

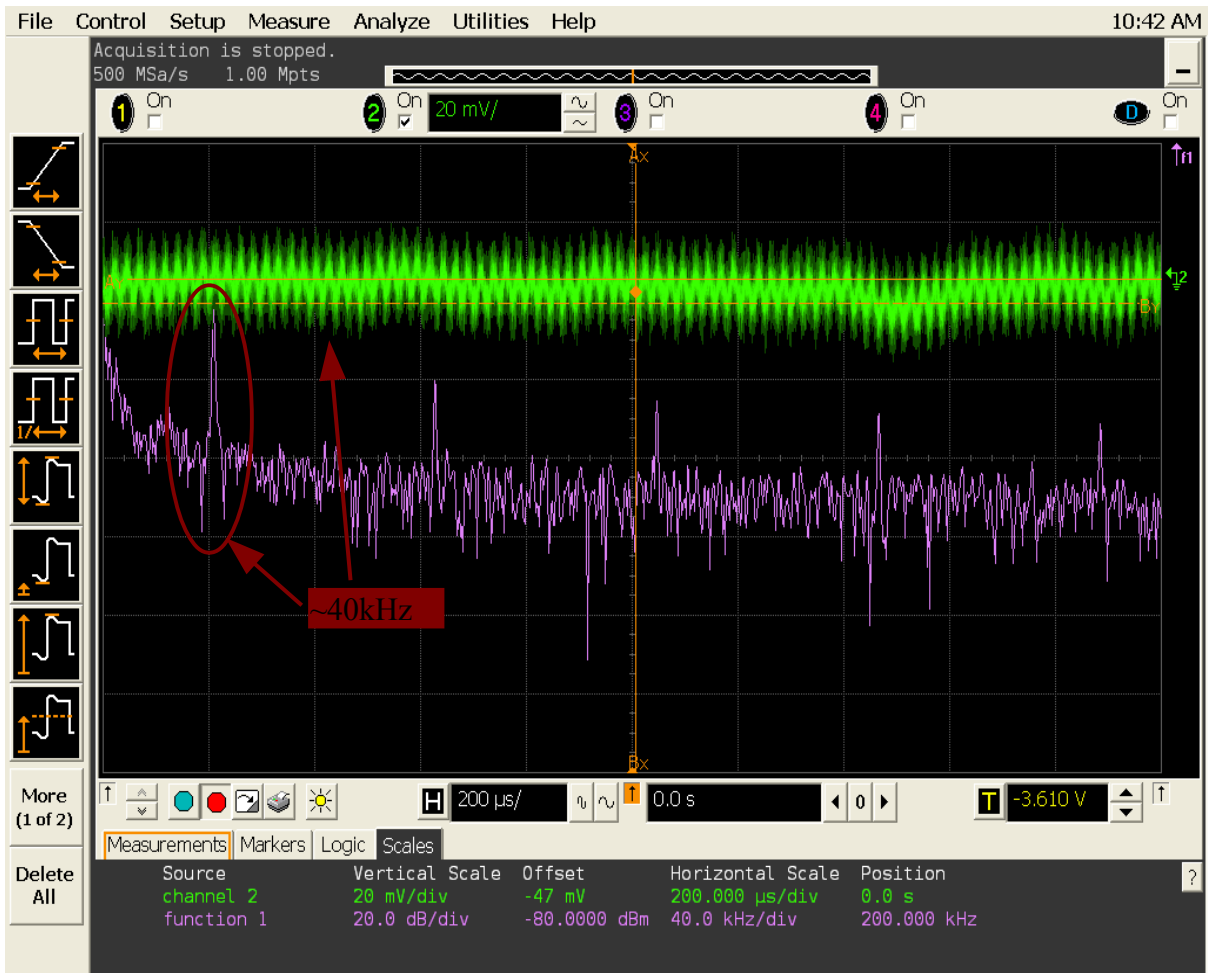
Pic-bg032702: A zoom-in look of Pic-bg032701. It's clear that the 40kHz periodic noise exists in the background.

The 40kHz noise is from the Fluorescent lamps. As I turned off the lights, the 40kHz periodic noise disappeared. You can find more information at:

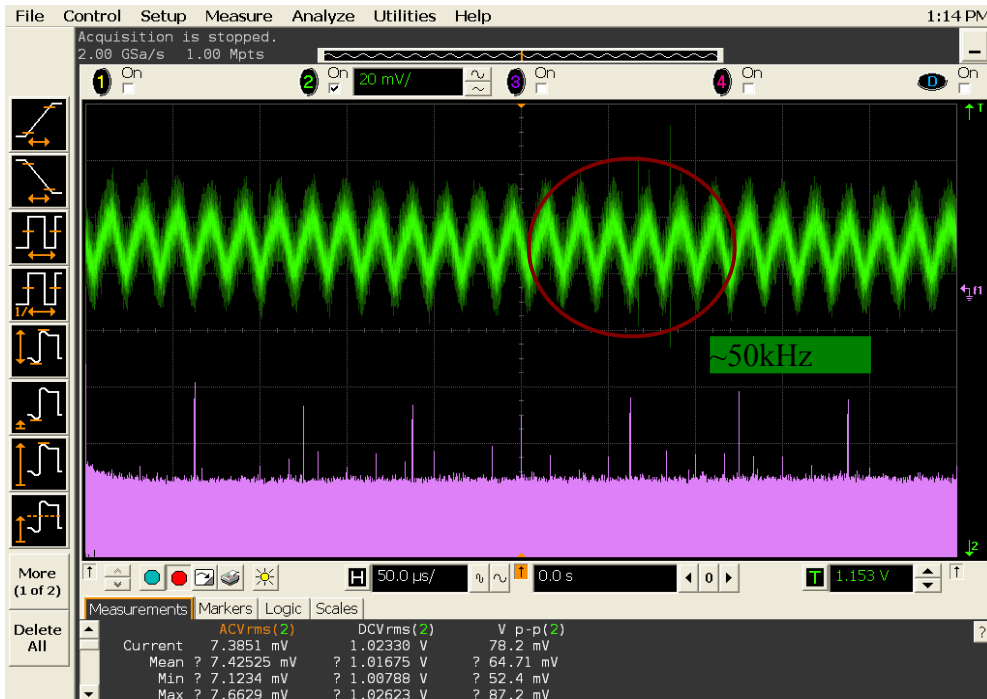
Without an input by-pass Tantalum capacitor, the periodic noise always appears even with an output by-pass Tantalum capacitor.

Pic-PAC14.03: CX1 was replaced with a 2.2 μ F Tantalum capacitors and CX2 was removed on carrier board#14.

FFT Scale: vertical=20dB/div; offset=-45dBm
horizontal=100MHz/div; position(center line)=500MHz

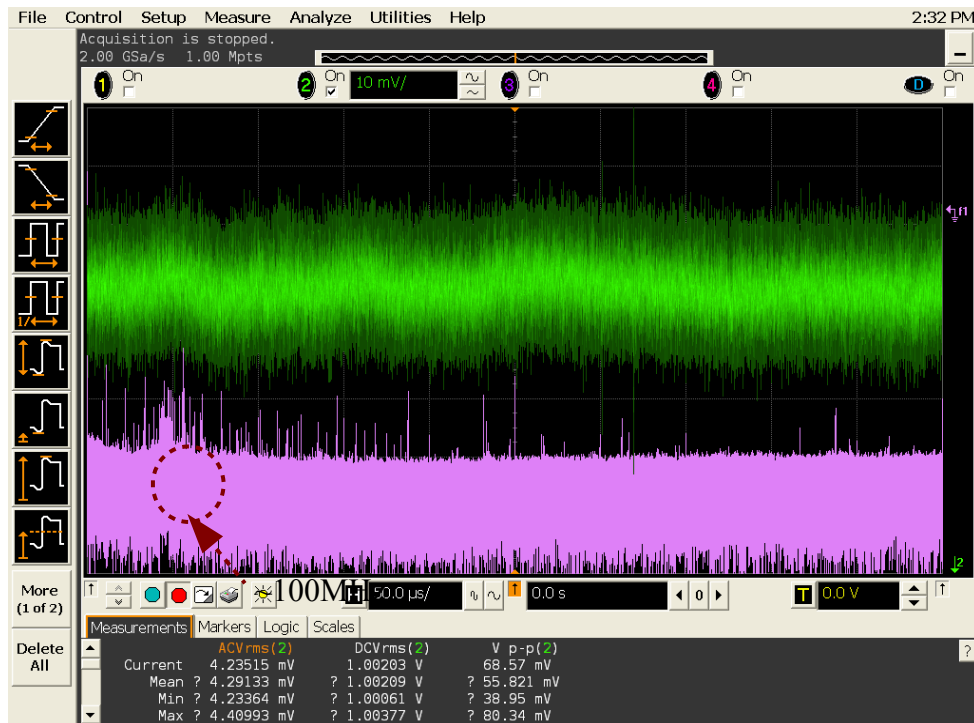
Pic-PAC14.05: Both CX1(output) and CX2(input) were replaced with 2.2 uF Tantalum capacitors.

FFT Scale: vertical=20dB/div; offset=-45dBm
horizontal=100MHz/div; position(center line)=500MHz

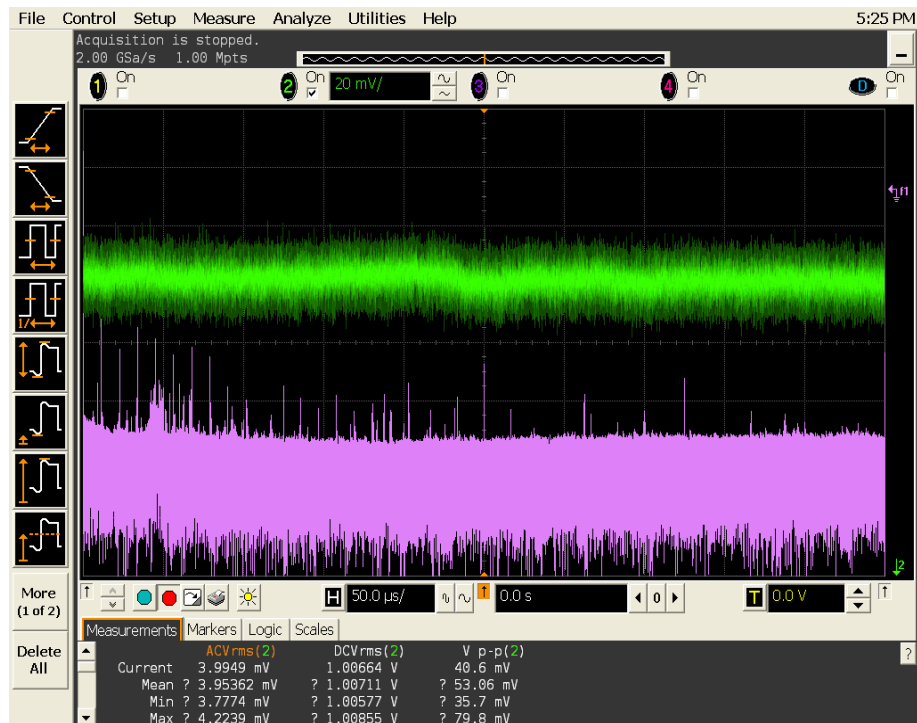
Pic-PAC12.16: No capacitor on CX1 and 2.2 μ F Tantalum Capacitor on CX2.

15 preamps on the carrier.

FFT Scale: vertical=20dB/div; offset=-45dBm

horizontal=100MHz/div; position(center line)=500MHz

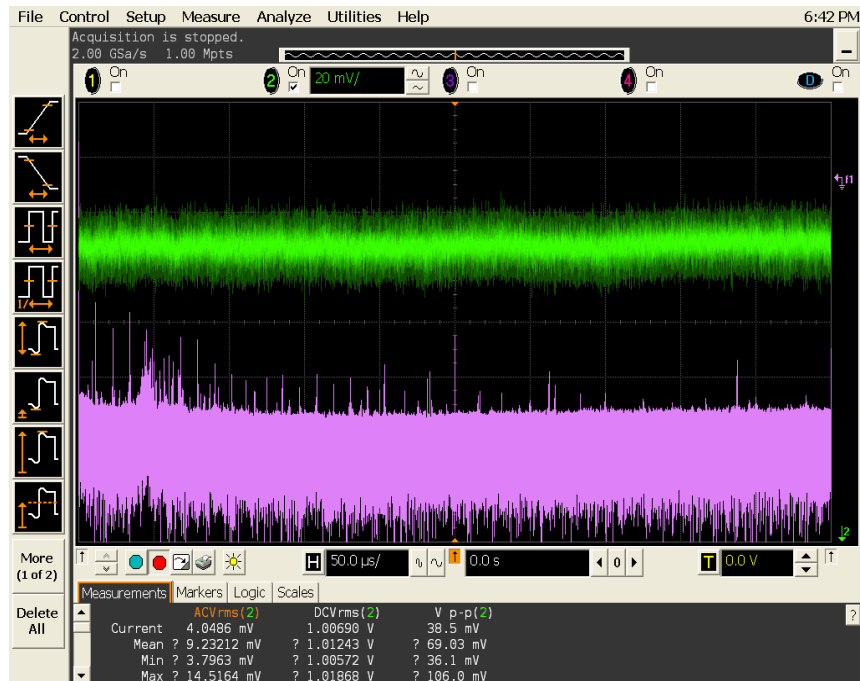
**Pic-PAC11.25: 2.2uF Tantalum capacitors on both CX1(output) and CX2(input).
15 preamps on the carrier.**

FFT Scale: vertical=20dB/div; offset=-45dBm
horizontal=100MHz/div; position(center line)=500MHz
