TOP TRG/DAQ status

2016-09-07 updated with text of responses from DAQ members

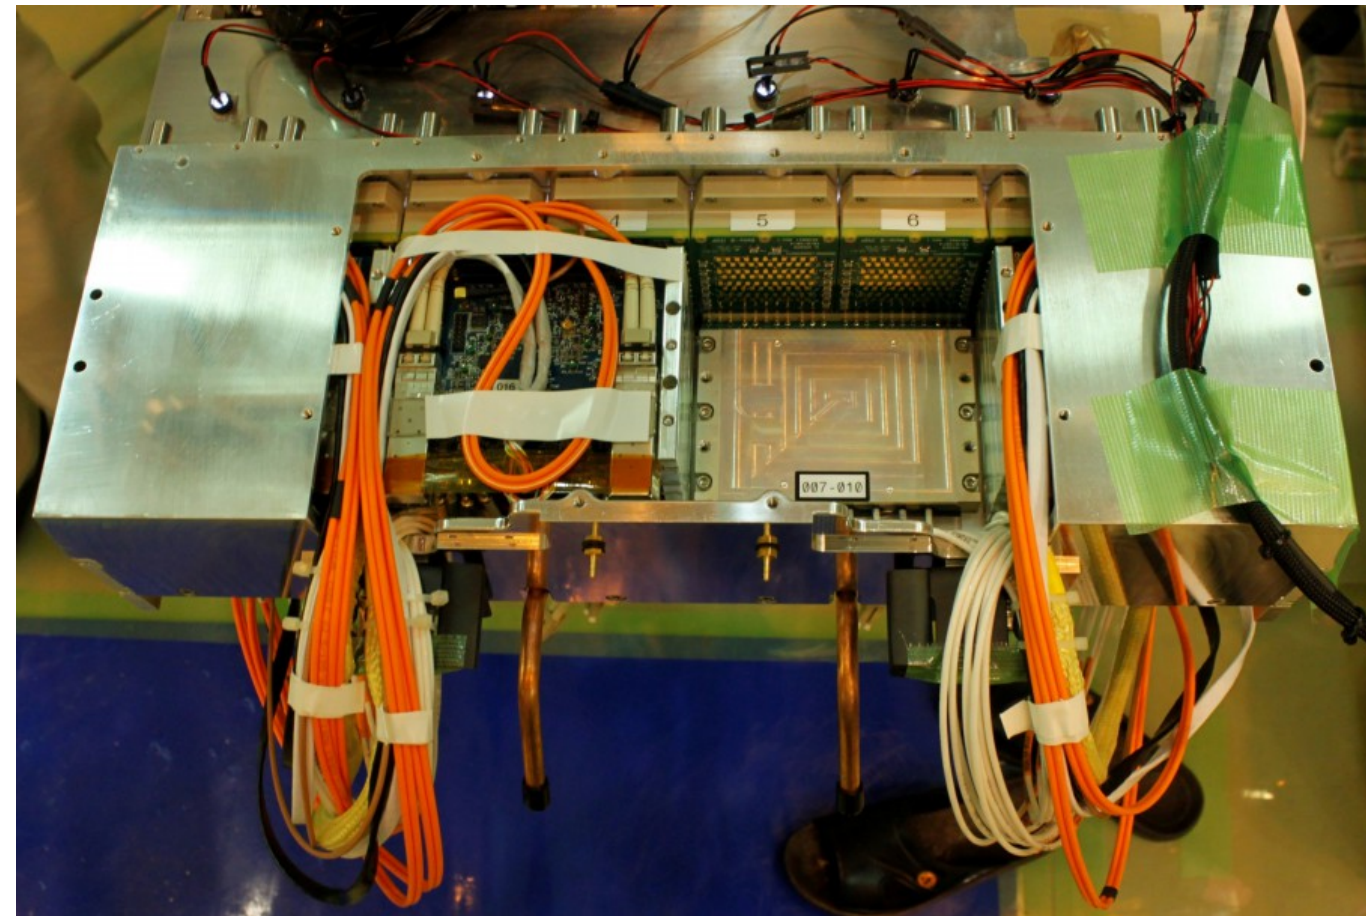
environment monitoring

- via snmp:
 - Wiener LVPS (192 currents, 384 voltages)
- via TCP/IP socket:
 - Caen HVPS (512 currents, 512 voltages)
- via copper local bus / hslb / fee:
 - humidities (1/scrod)
 - temperatures (20/scrod)
 - voltages (74/scrod)
 - currents (37/scrod)

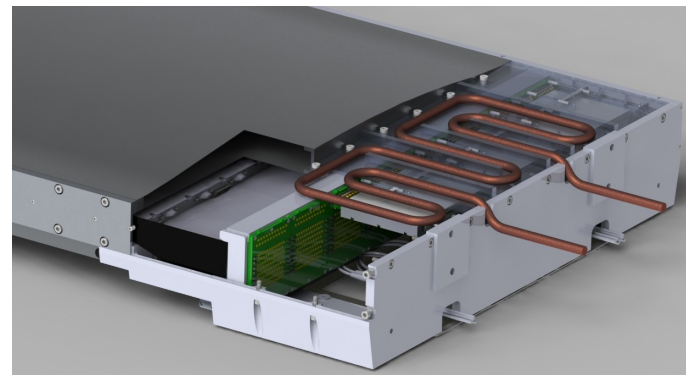
interlock

- hardware interlock:
 - magnet quench
 - chiller failure
 - water leak
- software interlock:
 - LVPS
 - I over/under/trip
 - V over/under
 - HVPS
 - I trip
 - V over/under
 - temperature
 - humidity
 - PMT hit rate

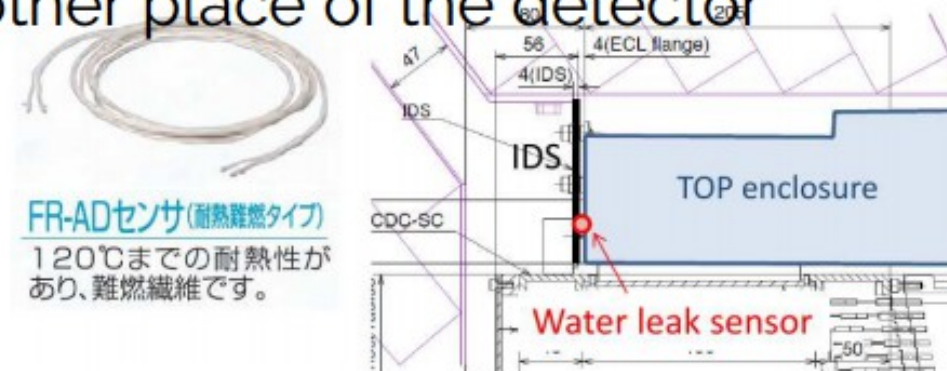
- LVPS, HVPS, interlock are in operation
- HV control is based on ARICH system developed by Konno + Yonenaga (no GUI yet but to be straightforward)
- LV control is in operation (GUI should be similar to HVPS)
- Info collected from Belle2link is needed
- Same water leak sensor to be used in the other place of the detector

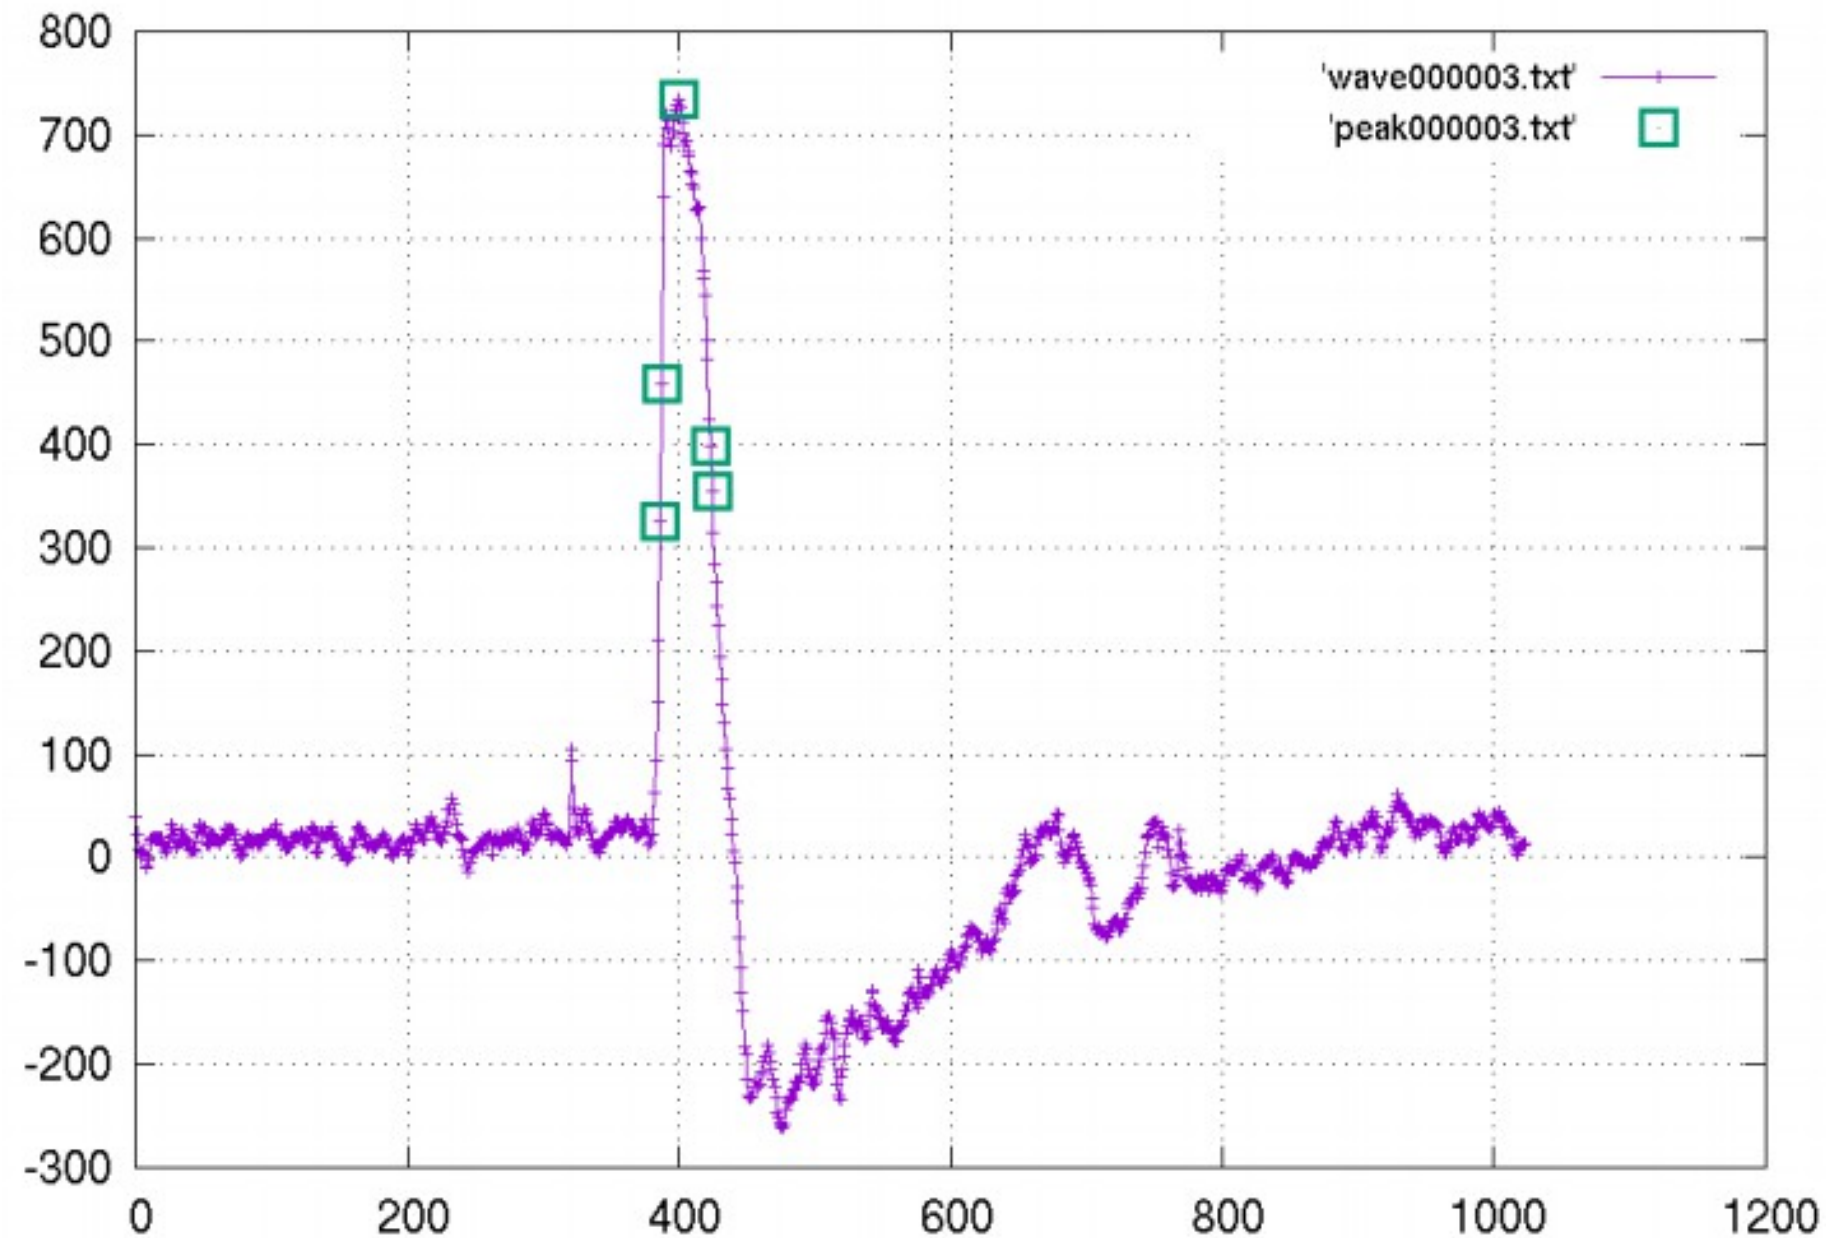
online feature extraction (FE)

- pedestal subtraction
- peak detection
- both implemented in "c"

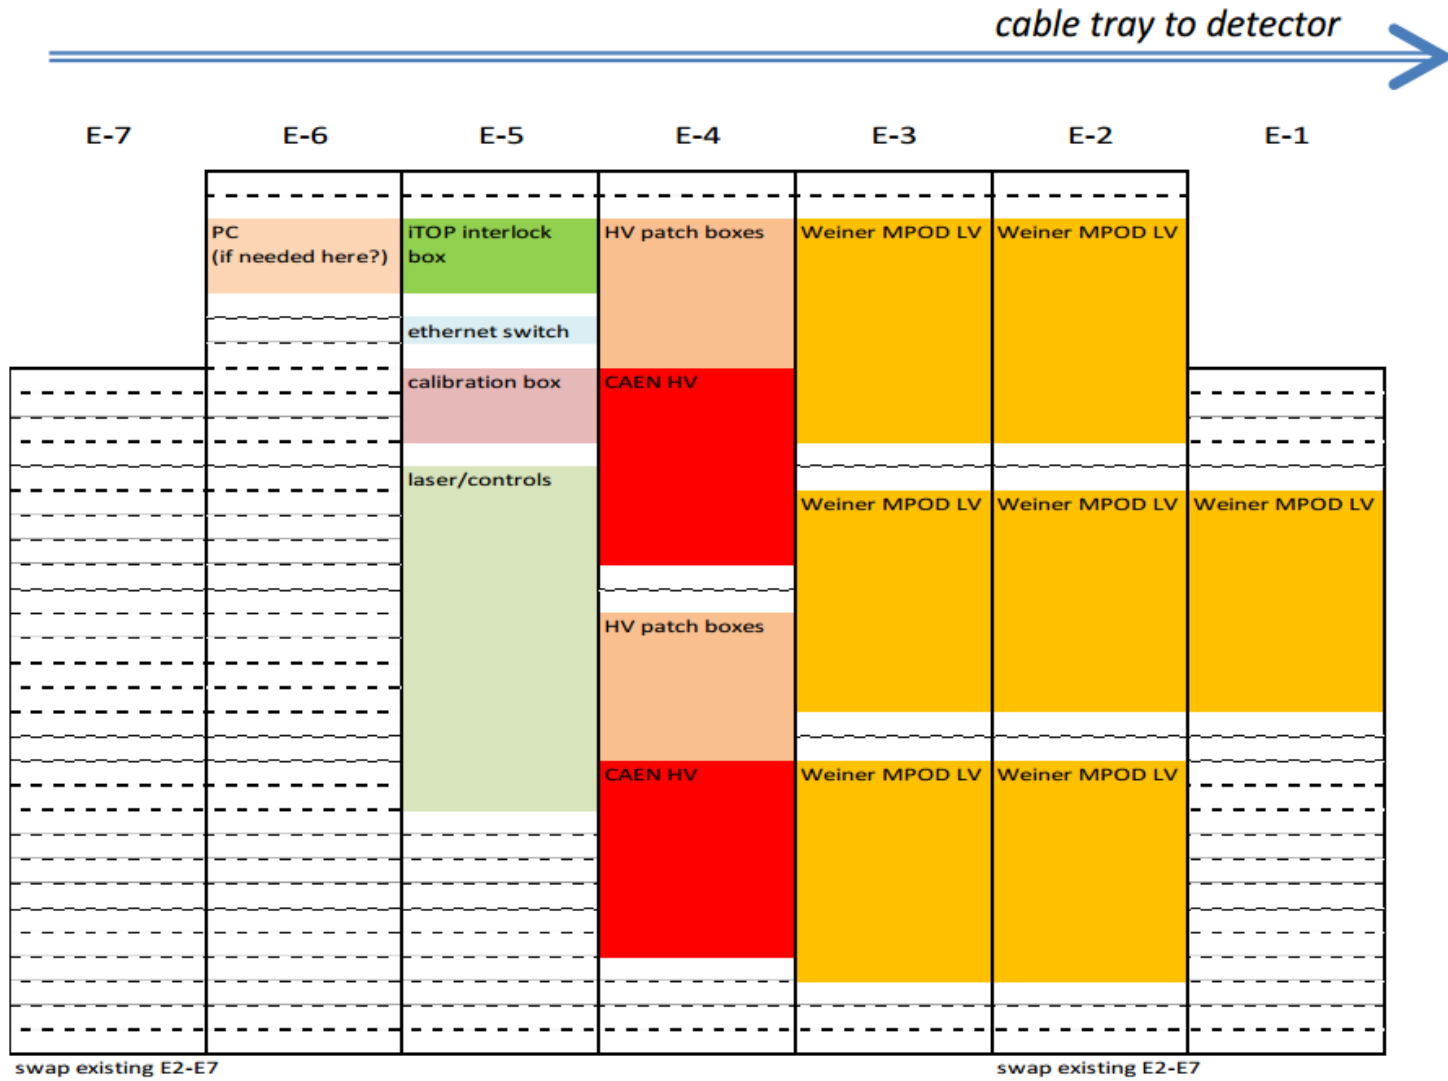
E-hut

- [need to find updated diagram]

- currently:
 - top01 used for DAQ on slots01-08
 - top03 used for DAQ on slots09-16
 - top02 used for DAQ on "module01" (CDC+TOP test)
 - toptest01 used for programming boardstacks, controlling LVPS(/HVPS?), etc
- would be nice if the filesystem were common (ldap+nfs)
 - Yamada: doubling up on nfs mounts (bdaq to ROPC; then ROPC to COPPER) is not planned at this time
 - at least common between top01 and top03 would help
 - homes mounted from bdaq would be ideal
 - Nakao: bdaq home is exported but not mounted (update: now mounted)
 - is this possible for "b2top" user as well, or is that prohibited?
- is there a plan to change the administration method on topNM (and other subdetectors' DAQ machines) during the SL5->SL6 upgrade?
